Job Report Cold Recycling

# WR 2500: Foamed bitumen rehabilitation near Los Baños, California / USA

### In situ foamed bitumen rehabilitation San Luis & Delta – Mendota Water Authority Canal Road, Los Baños District, California

Mike Marshall, August 2000

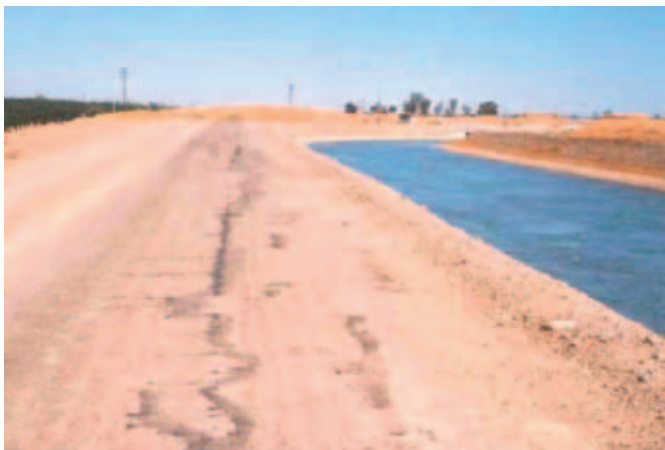
Initial investigation of the site showed poor surface shape, severely distressed surfacing with wide longitudinal cracks. The proposed solution was to recycle the existing pavement with the Wirtgen WR 2500 using foamed bitumen as the binding agent.

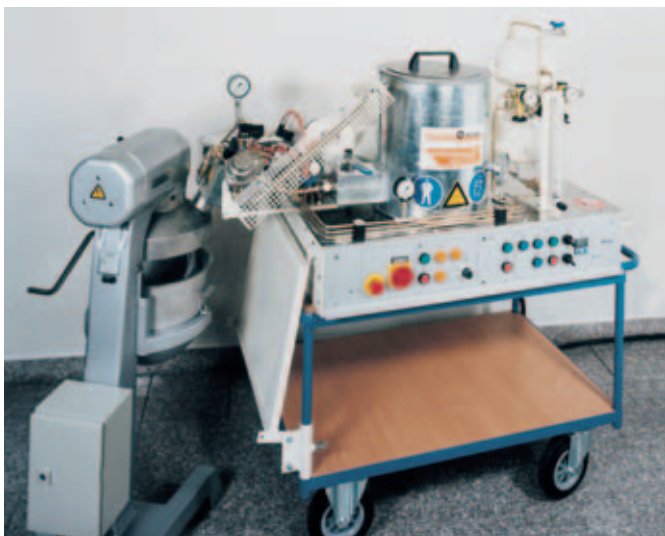
Wirtgen WLB 10, foamed bitumen laboratory unit was used to determine optimum mix design

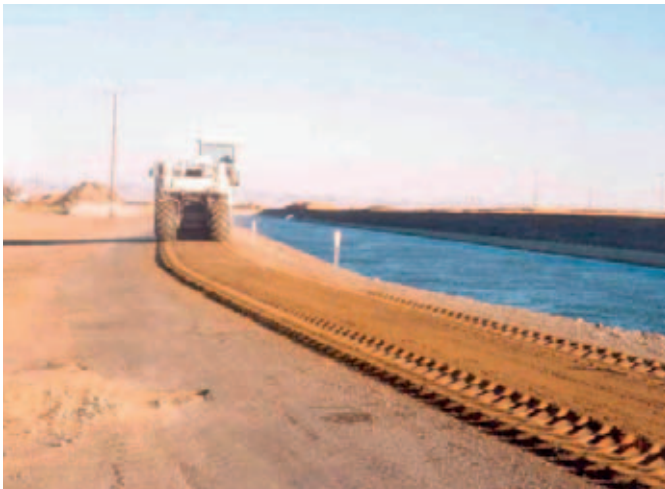
As the road was severely distressed and out of shape it was necessary to pre-pulverise the entire section. This operation allows the road to be put into a more uniform shape prior to the recycling operation.

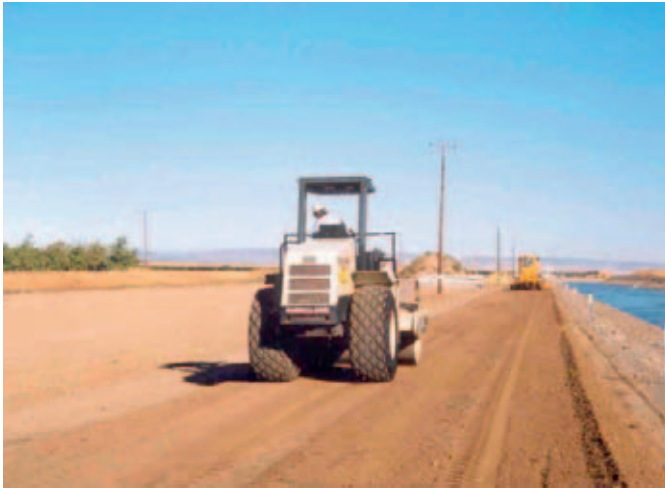
Grader and compactor pre-shape road after pulverisation.

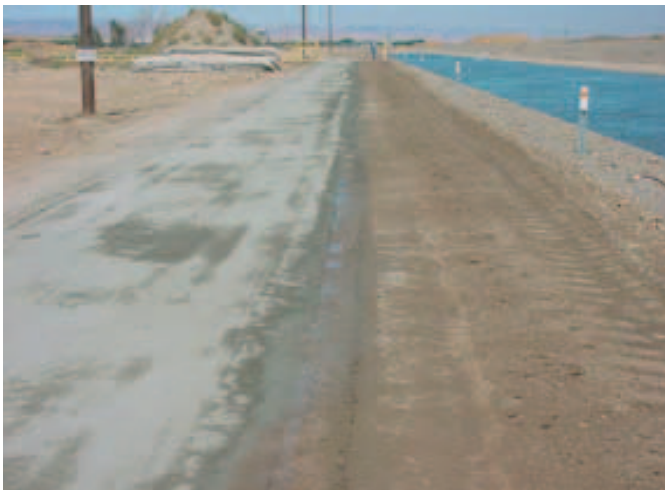
Cement (1.5 % by mass) spread onto pulverised and pre-shaped road surface prior to foam bitumen recycling.

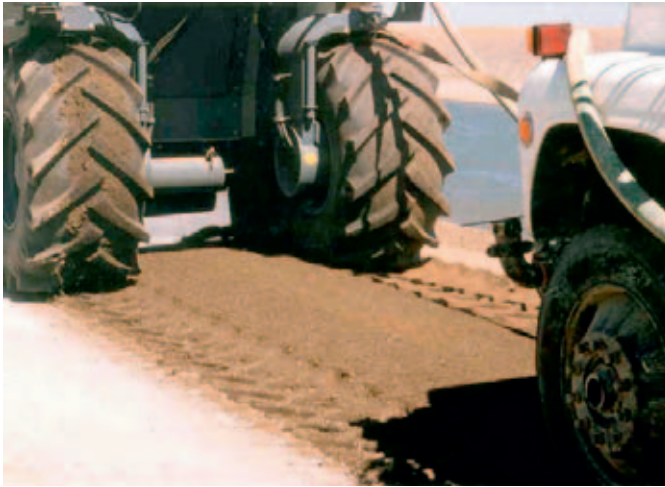
Road material after recycling with foamed bitumen (view between rear of WR 2500 and front of water cart).

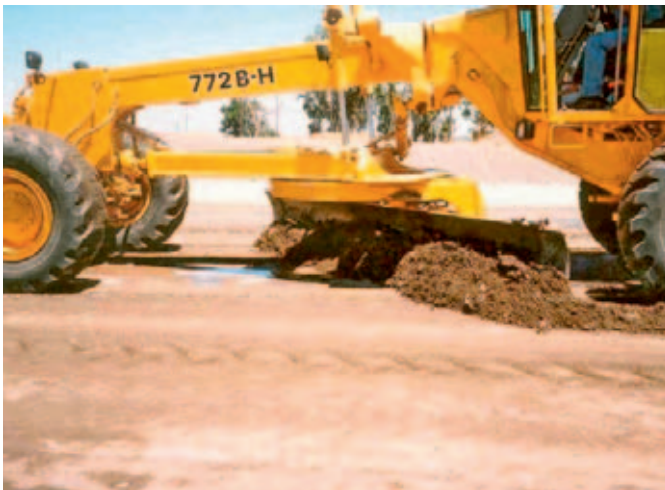
Following initial compaction with the steel drum compactor, the grader is used to cut the road to the required levels. The foam bitumen recycled material flows easily off the grader blade.

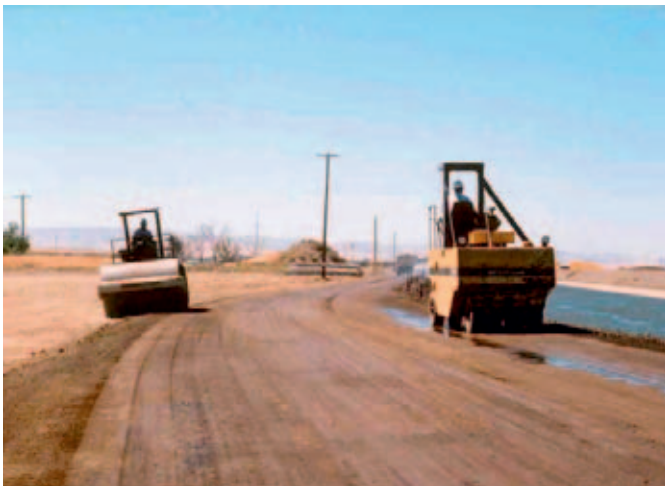
Required compaction achieved with 12 ton steel drum compactor. Surface finish compaction by means of multi tyred pneumatic compactor.

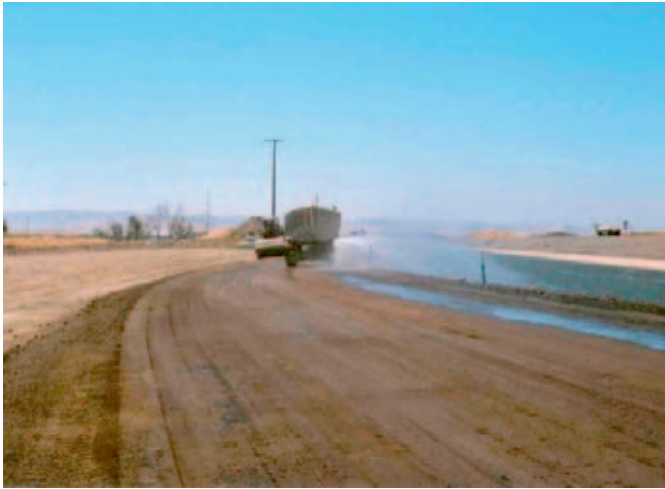
To ensure a close knit surface finish, it is essential to liberally water the recycled surface when compacting with the pneumatic tyred compactor.

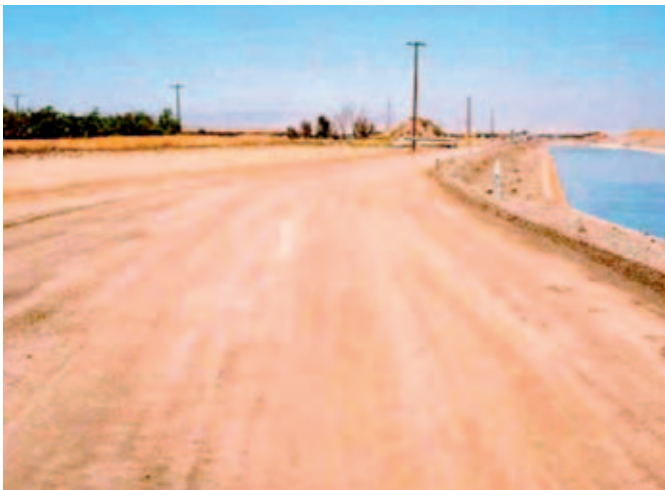
An excellent surface finish can be achieved, providing a smooth running surface.
