Job Report Cold Recycling

# WR 2500: Foam recycling project, Canyon de Chelly / Arizona

## WR 2500: Canyon de Chelly FHWA foam recycling project

Mike Marshall, March 2003

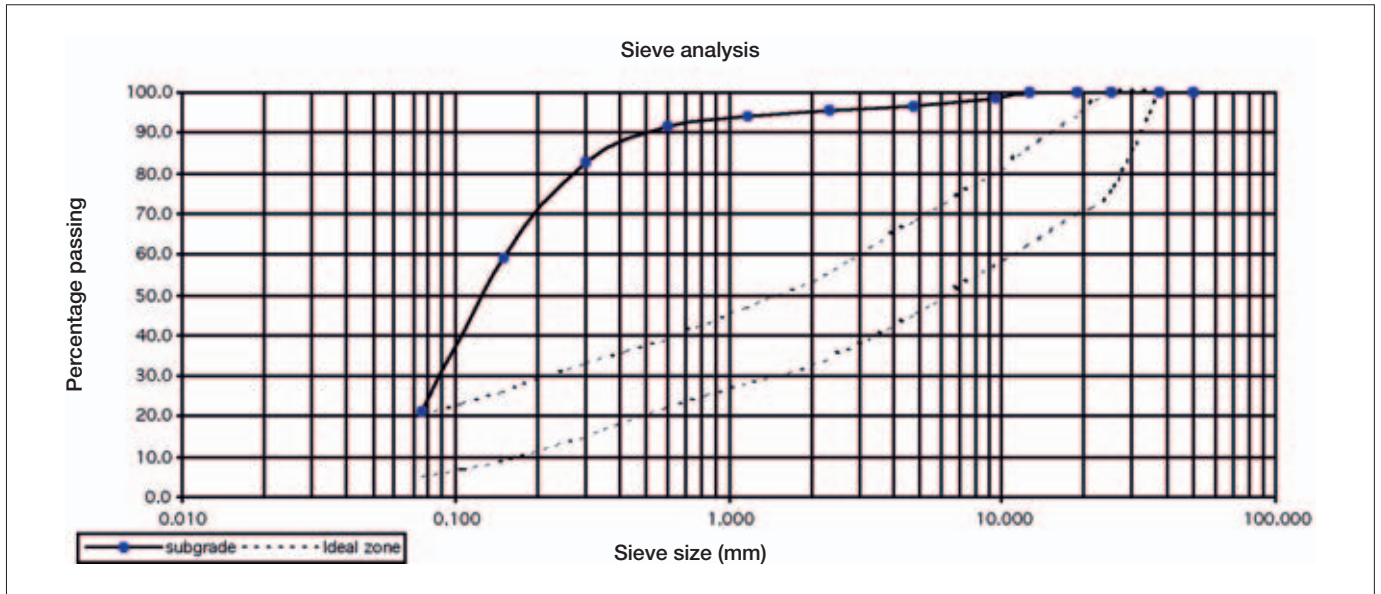
Figure 1: Gradation of subgrade material from South Rim Road

The subgrade material was fairly sandy and therefore 50 mm of this material was incorporated into the blend. The gradation of the subgrade material is shown in Fig. 1 below.

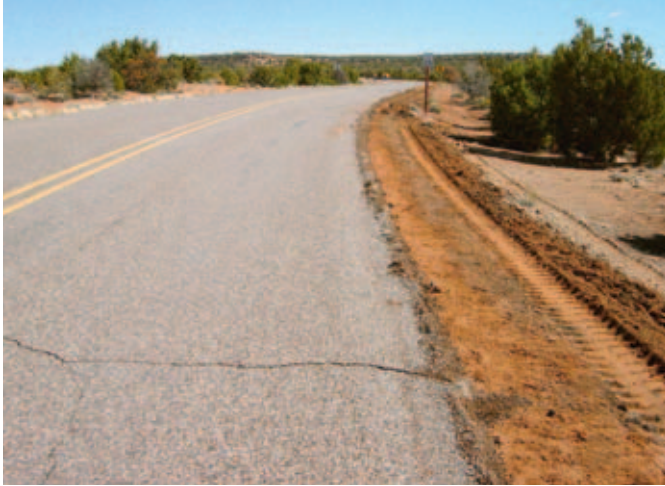
Prior to recycling all vegetation is cleared from the road edge using the motor grader blade.

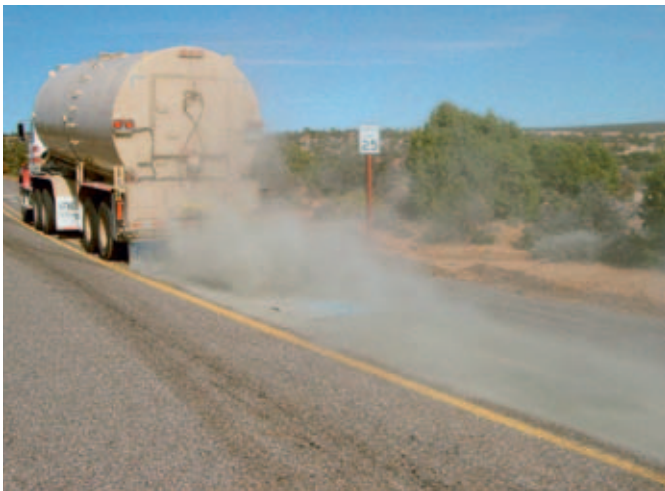
As specified in the mix design 1 % cement is spread onto existing pavement.

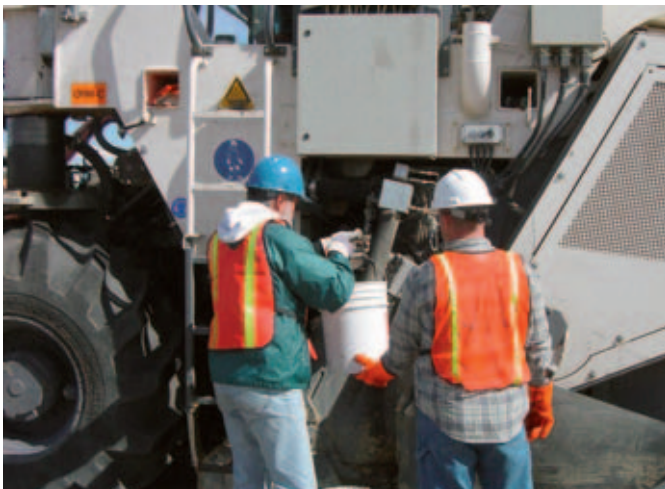
A sample of foamed bitumen is taken from the side test nozzle of the WR 2500.

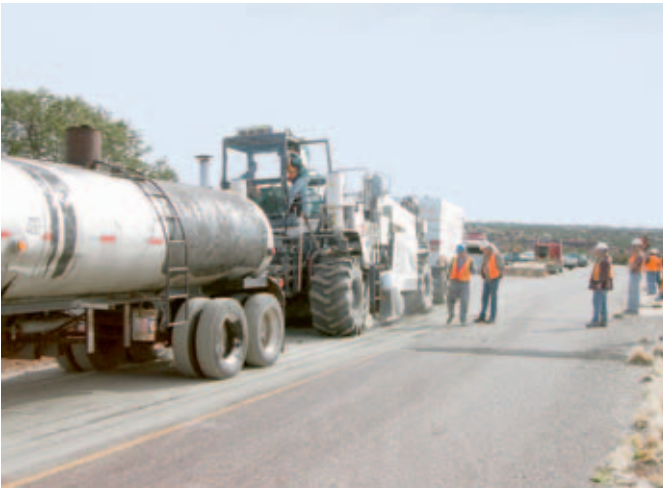
The recycling train consists of:

- ▶ WR 2500 recycler
- ▶ Bitumen supply tanker
- ▶ Water cart

The WR 2500 recycler pushes the oil tanker and pulls the water cart.

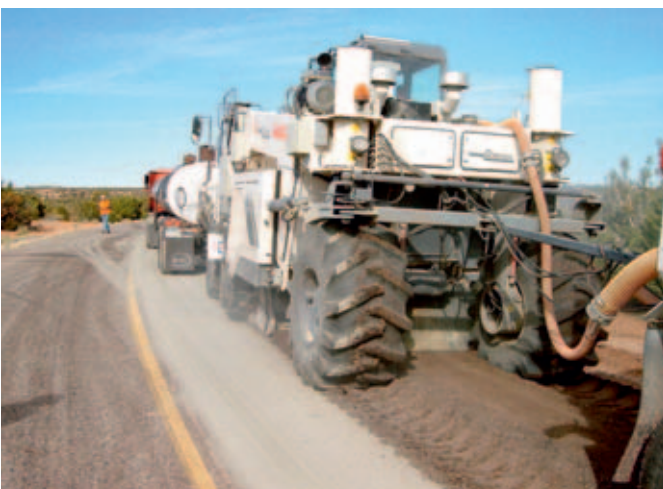
The WR 2500 recycler simultaneously:

- ▶ Pulverises the pavement
- ▶ Mixes in the cement
- ▶ Adds 3.0 % foamed bitumen
- ▶ Adds required amount of moisture for compaction
- ▶ Maintains the required depth

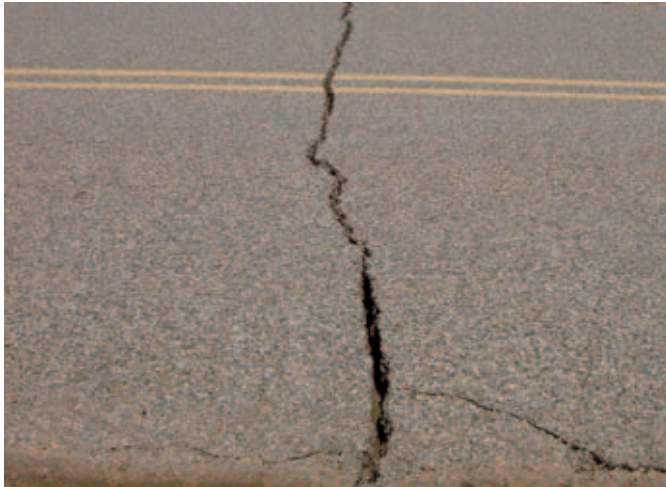
Where cracks in the pavement are full depth it is essential that the recycler be capable of cutting through the existing asphalt into the base, thereby eliminating any possible reflective cracking in the future.

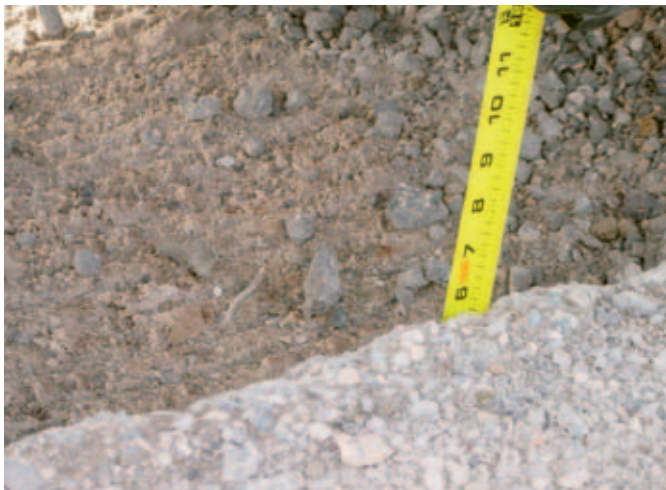
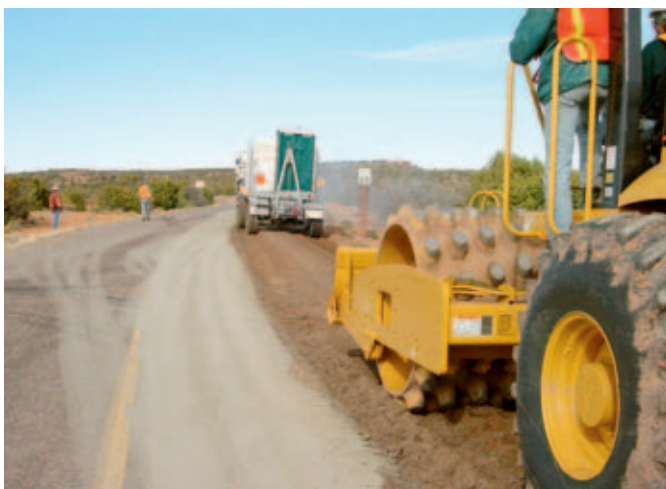
A vibrating padfoot compactor follows immediately behind the WR 2500 for initial compaction of the recycled material.

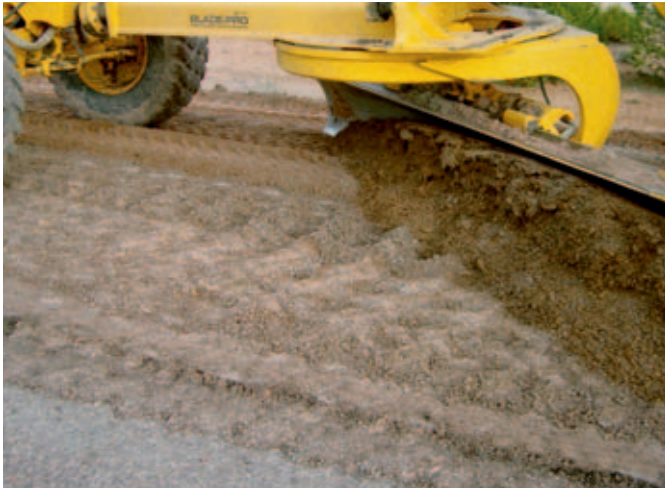
Following the initial compaction, a motor grader is used to cut the recycled material to the desired levels.

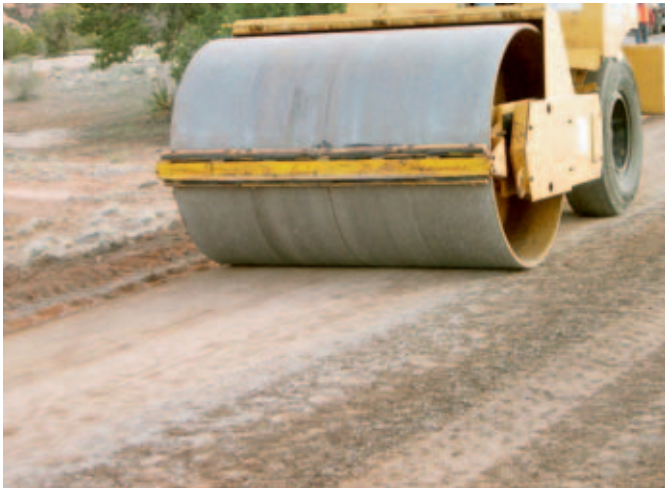
A steel drum vibrating compactor follows the motor grader after the final levels have been cut.

The required densities should be achieved after the required number of passes with the steel drum compactor.

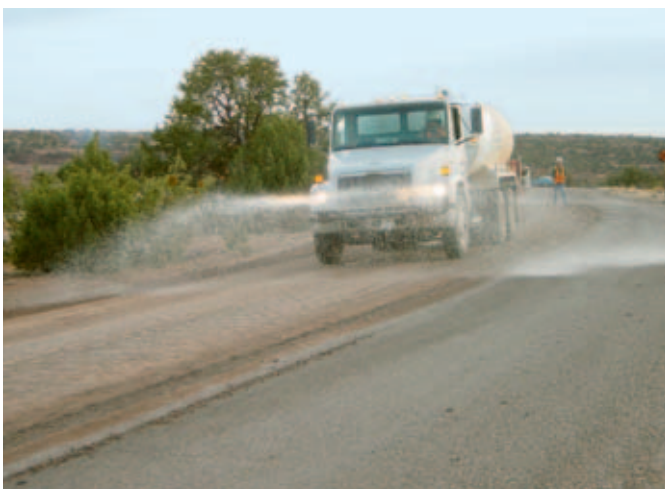
The finished compacted sections are lightly watered.

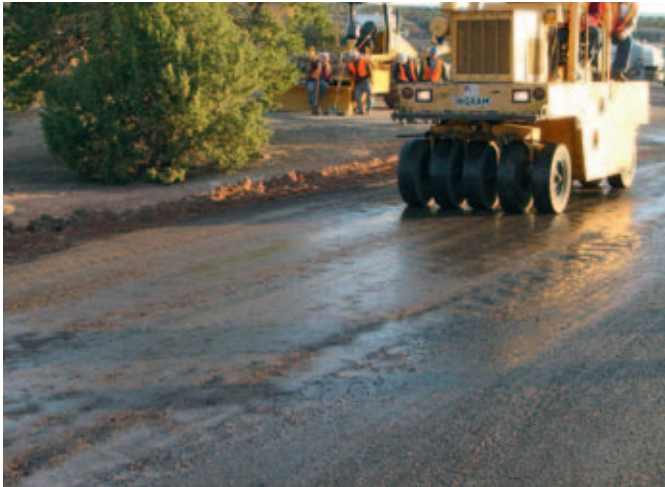
While the finished compacted recycled material is moist, a pneumatic tyred roller is used to achieve surface finish. The rolling action of the tyres creates a “slush” bringing fines to the surface which form a closely knit surface for traffic to run on. At this stage the recycled section can be immediately opened to traffic.

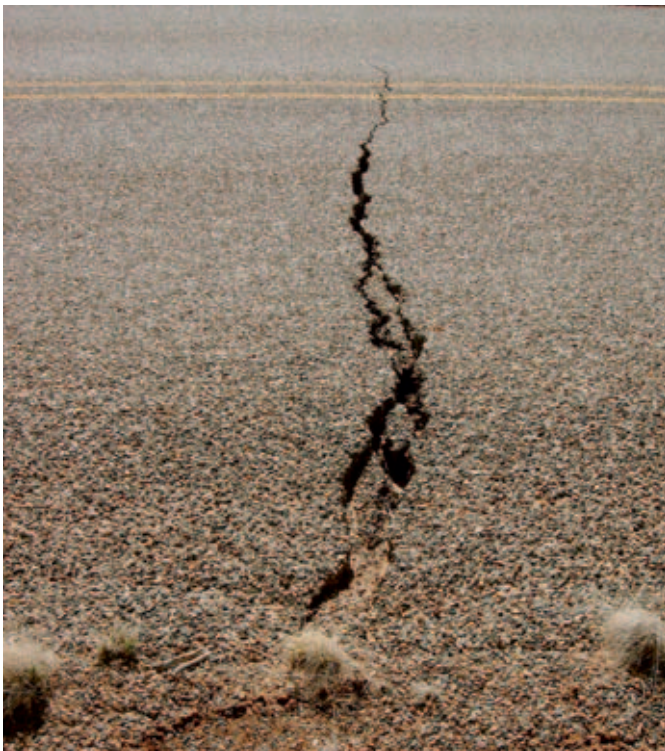
Full depth cracking through the asphalt pavement.

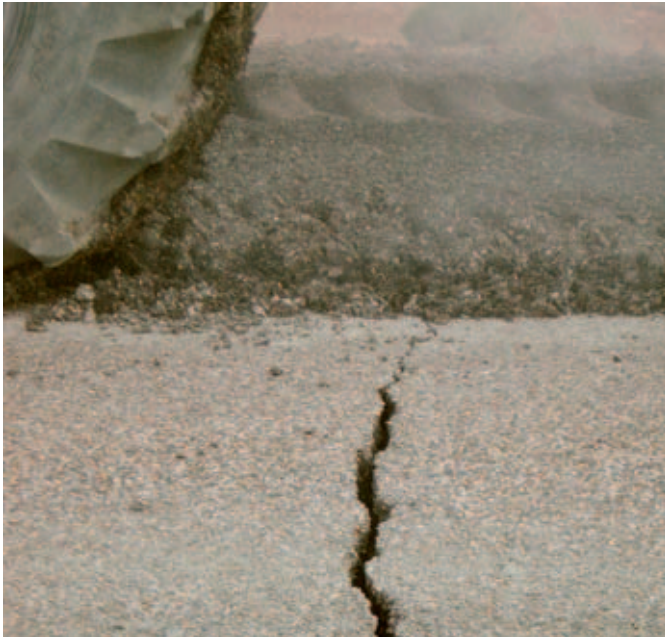
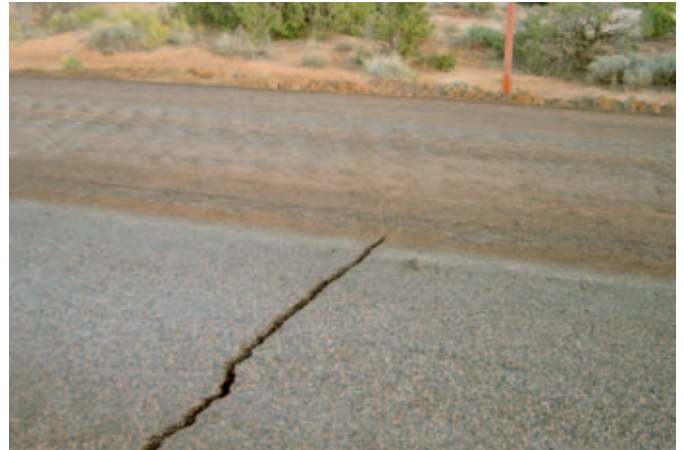
The recycler cuts through the asphalt into the base eliminating the crack.

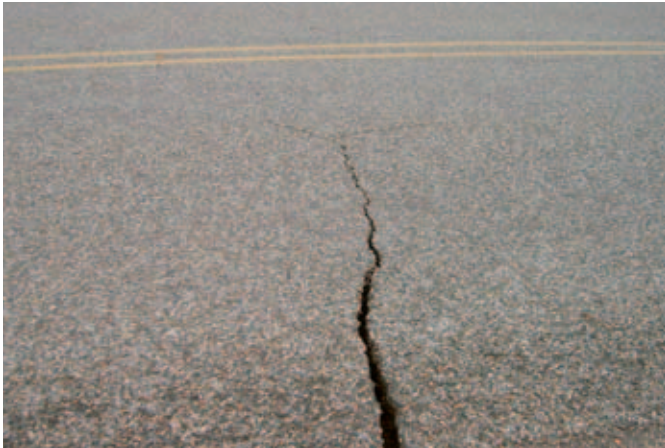
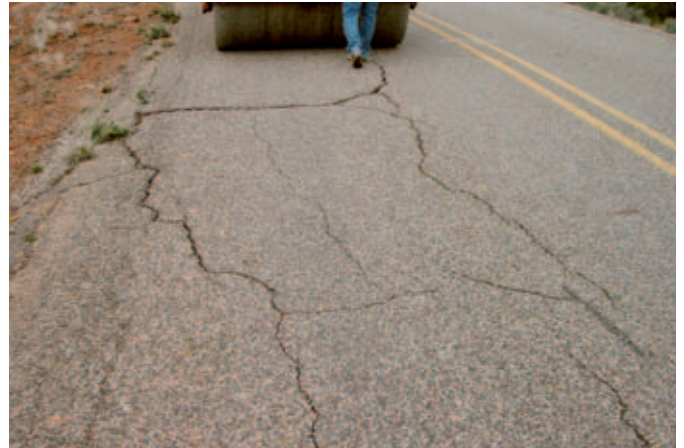
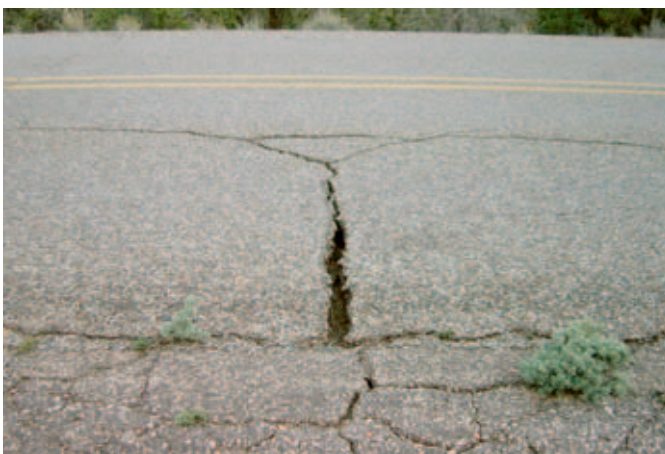
Typical views of the pavement condition prior to recycling.

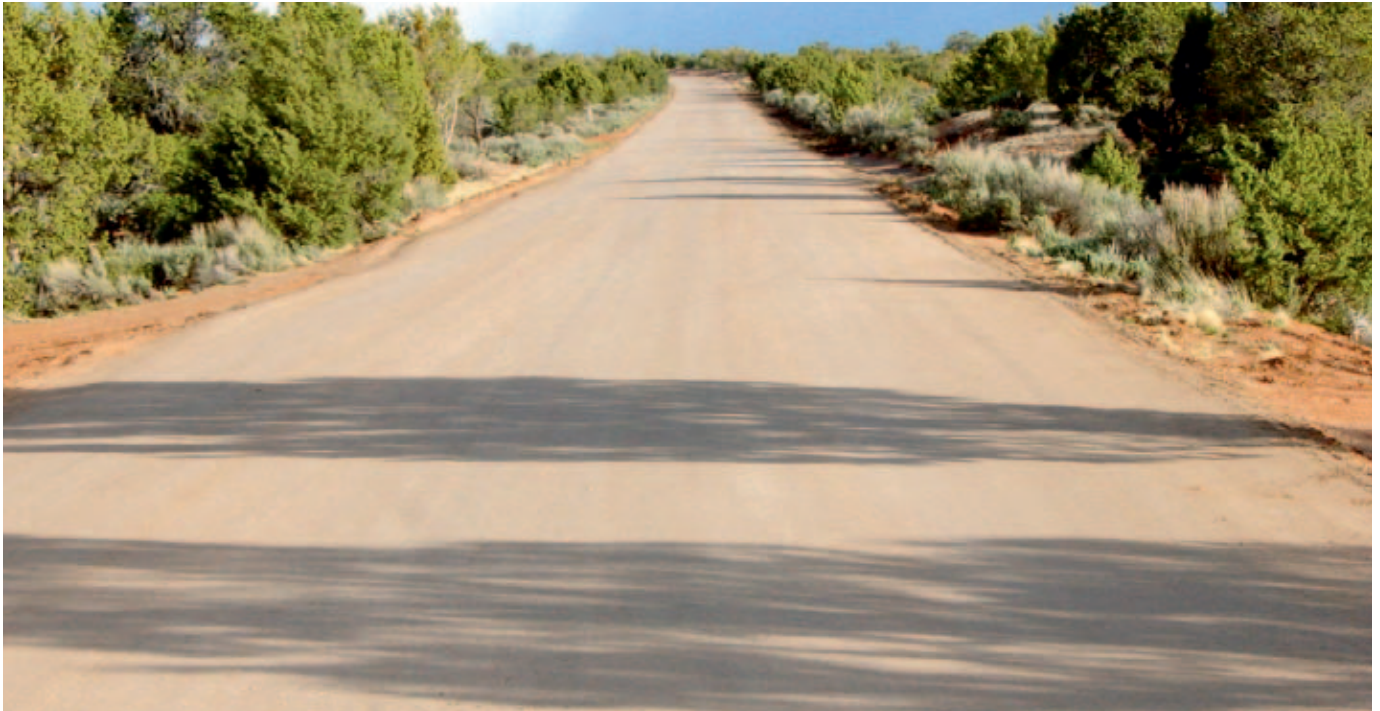
Recycled pavement finish shaped and compacted prior to overlay.
