Job Report Cold Recycling

# WR 2500: Cold foam in place recycling, Eilerslie Road, Edmonton / Canada

## Cold foam in place recycling Ellerslie Road, City of Edmonton, revisited

Mike Marshall, August 2001

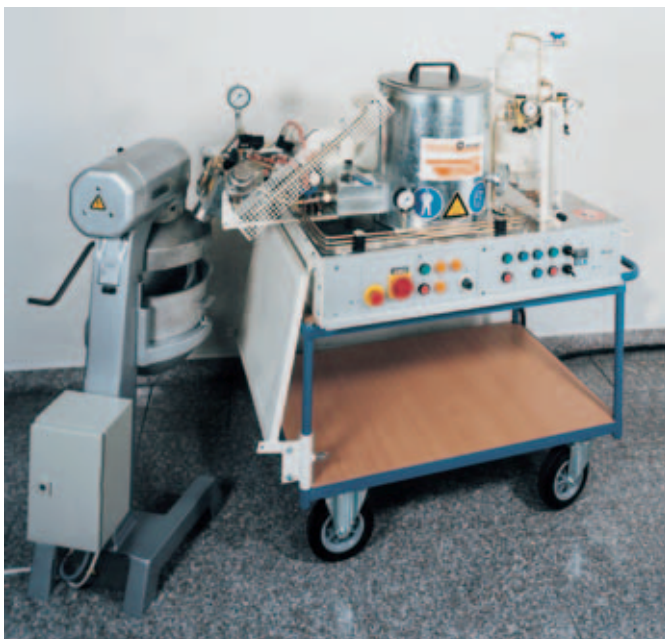
The WLB 10 is used to:

- Determine the foaming properties of different bitumen types.
- Producing samples by injecting foamed bitumen directly into the laboratory mixer.
- The quality of mixtures to be produced in the field can be defined exactly.
- Information on the material properties such as load bearing capacity can be obtained before the construction work starts.

Using a Wirtgen WLB 10, foamed bitumen laboratory portions of the samples were prepared by mixing them with various percentages of foamed bitumen to determine the optimum percentage of foamed bitumen to be added to meet the desired design requirement.

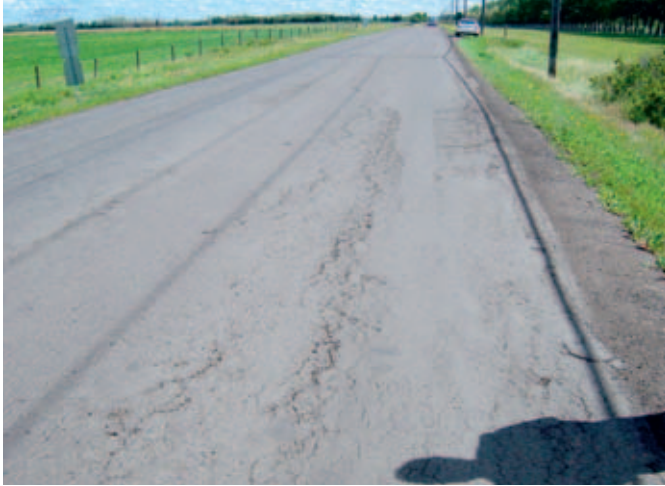
Ellerslie Road, Edmonton.

View from 156<sup>th</sup> Street looking East towards 142<sup>nd</sup> Street.

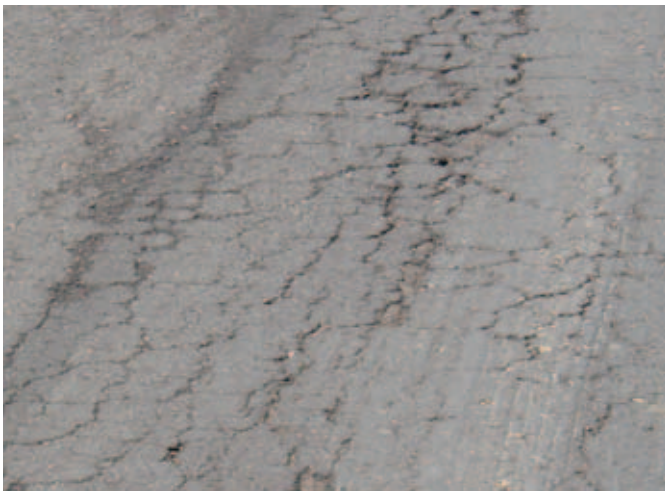
The distress found was mainly severe crocodile cracking and deformation.

The cracks are evidence of fatigue failure of the upper pavements layers due to lack of subgrade support, especially when the subgrade is excessively moist.

The deformation evident is also due to the movement of the subgrade and in some instances excessive bitumen in the base layer.

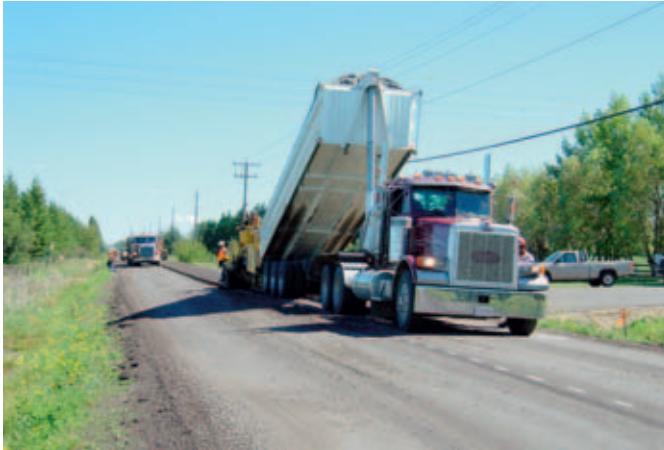
Locally sourced pit gravel, delivered to site by dump trucks.

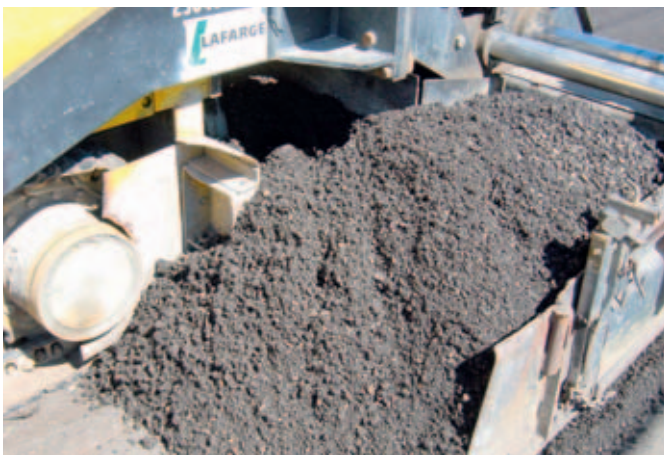
The pit gravel was laid using a conventional paver at thickness of 4" (100 mm).

The layer was roughly compacted to accommodate traffic.

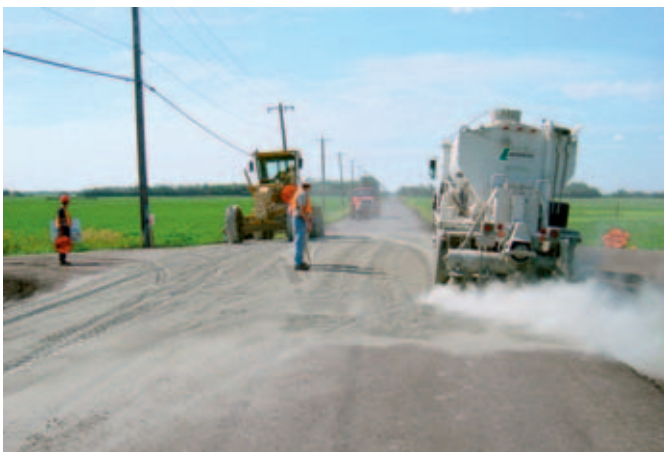
Cement, 1.5 % by mass was added to the surface of the compacted new material.

The cement was spread in sections, no longer than 450 m in front of recycling train.

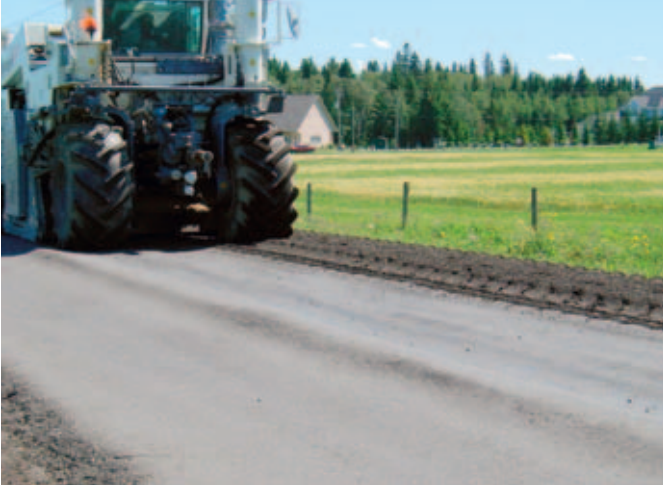
It was necessary to pre-pulverise certain sections of the pavement.

Rutting in excess of 6" (150 mm) West of 140<sup>th</sup> St.

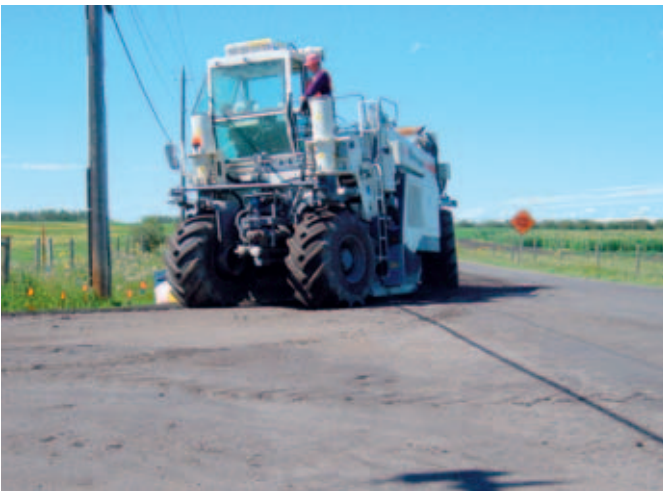
Pre-pulverising the Crossroad radius.

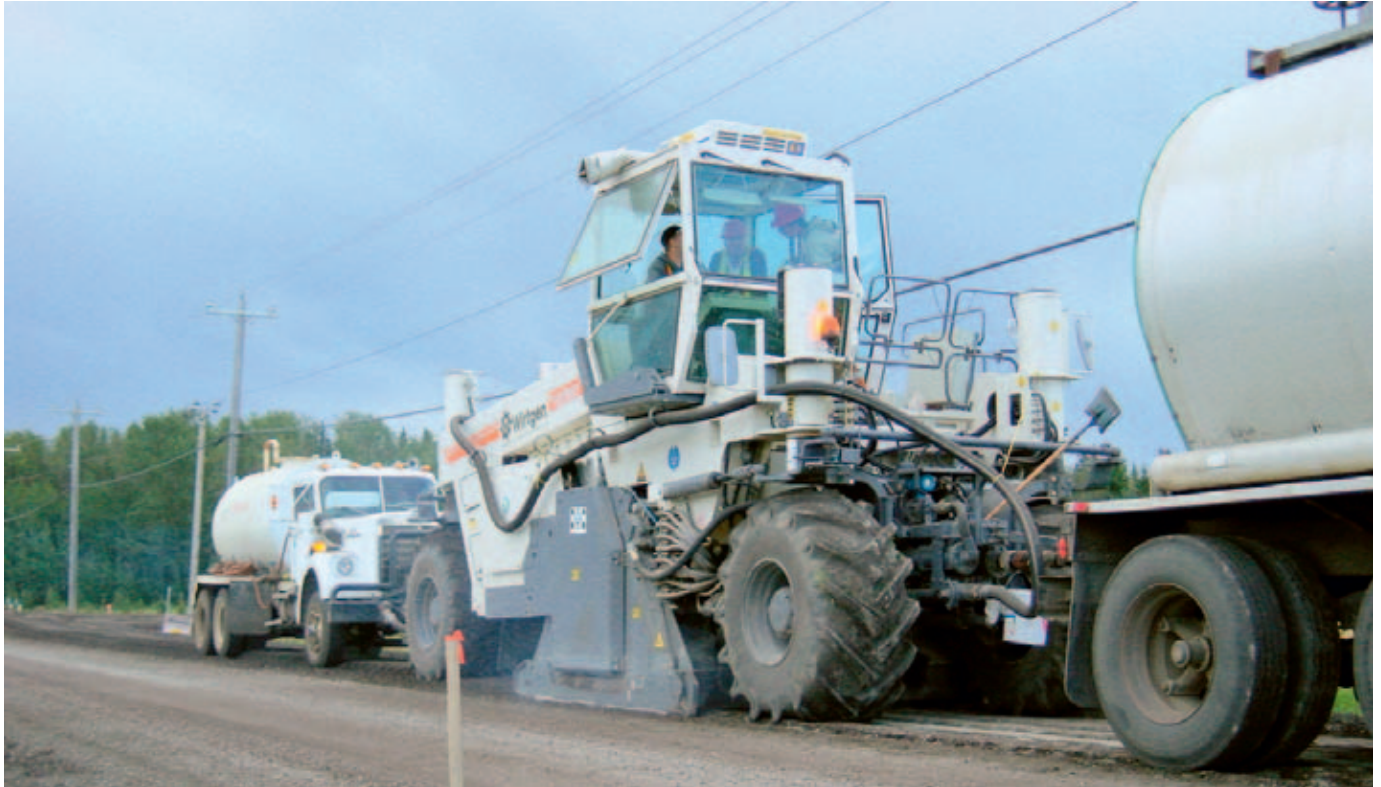
The WR 2500 recycler was coupled with:

- ▶ Bitumen supply tanker, in front, bitumen heated to a temperature of 350 deg F. The supply tanker is pushed by the WR 2500 recycler.
- ▶ Water cart, in rear. The water cart is pulled by the WR 2500 recycler.

The road width to be recycled is 25ft (8m), the number of passes with the recycler is four:

- Pass 1. East Bound Lane  
8 ft (2.5 m) full cutter width, with full foam spray bar open.  
Direction West to East
- Pass 2. East Bound Lane  
5.5 ft (1.7 m), from edge Pass 1. to center of road-

way (allowing for 6" overlap each edge)  
Outer foam jets switched off to avoid double dosing with bitumen.  
Direction West to East

- Pass 3. West Bound lane  
8 ft (2.5 m) full cutter width, with full foam spray bar open.  
Direction East to West

- Pass 4. West Bound Lane  
5.5 ft (1.7 m), from edge Pass 1. to center of roadway (allowing for 6" overlap each edge)  
Outer foam jets switched off to avoid double dosing with bitumen.  
Direction East to West

Average recycling speed 44 ft/min (14 m/min).

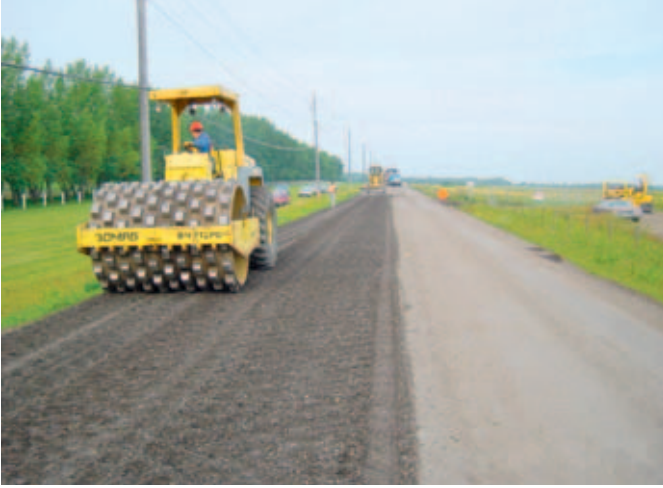
Vibrating padfoot compactor follows immediately behind the recyclers for initial compaction of the recycled material.

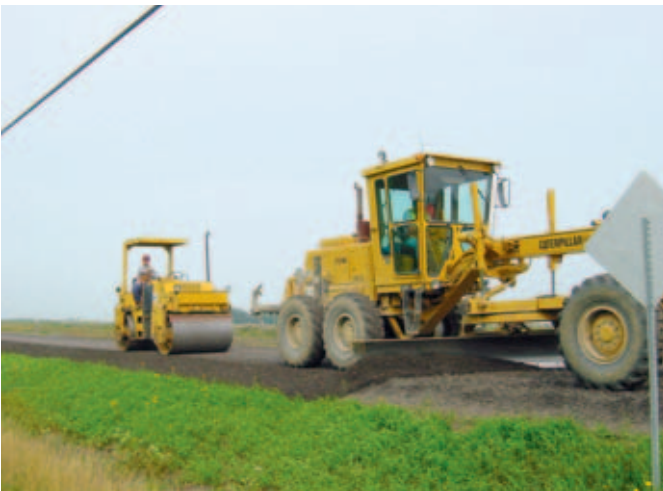
Once compacted the recycled material is cut to level using a motor grader.

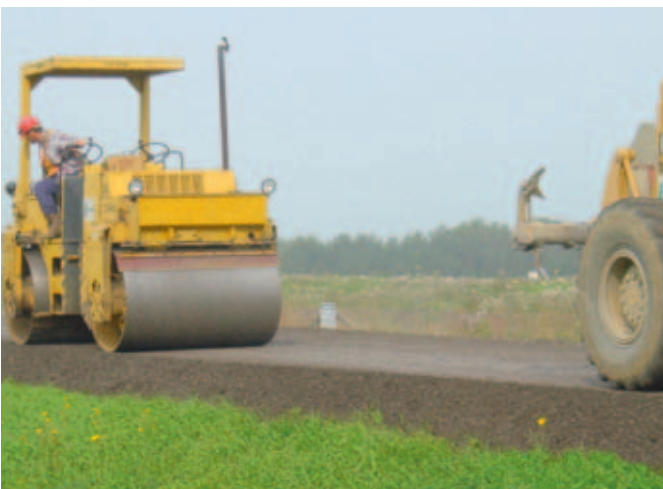
A double steel drum compactor follows the motor grader for final compaction.

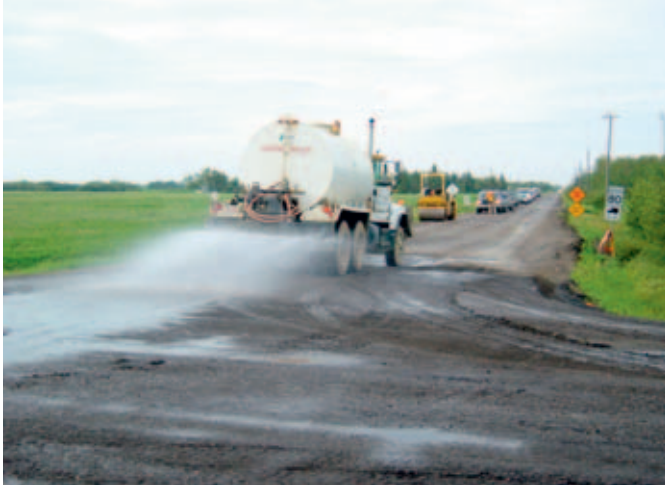
The recycled material is watered to keep the surface moist.

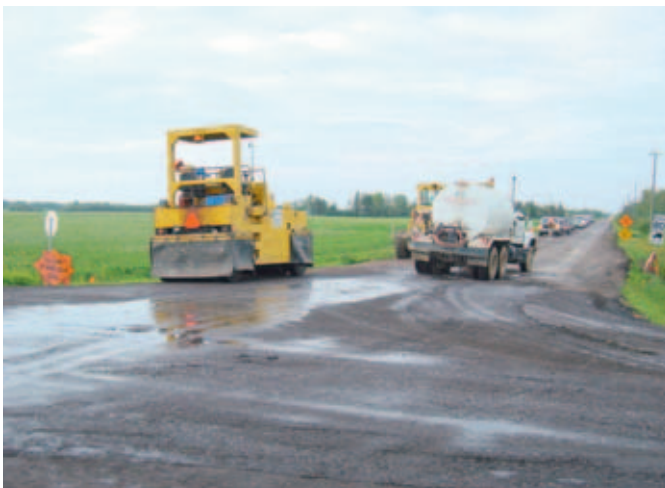
While the recycled surface is wet, the pneumatic tyred roller is used to create a surface slush effect, which knits together the finer particles at the surface.

This process locks the larger particles and avoids surface raveling.

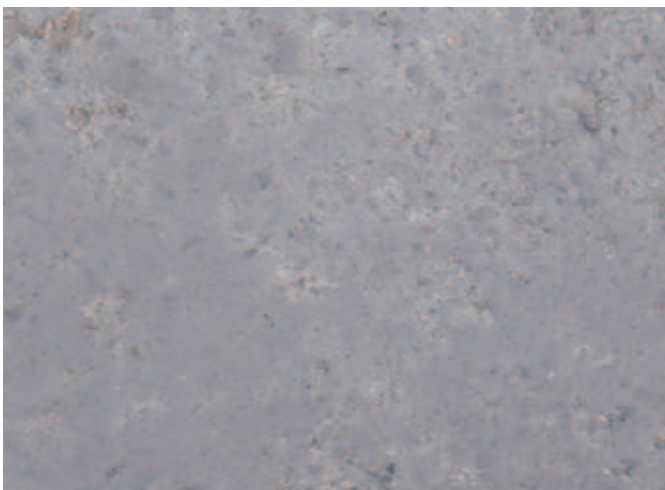
The resulting finish provides an excellent smooth surface for traffic to run on.

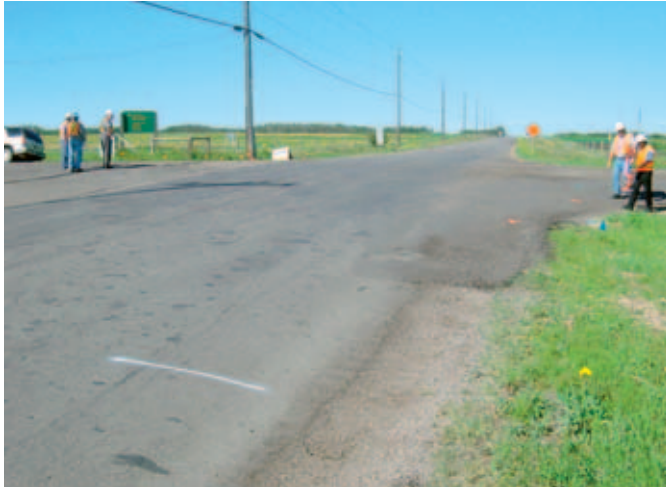
Junction Ellerslie Road and 156<sup>th</sup> Street, 4 way crossroad.

It was necessary to recycle this junction without closing off the traffic, therefore speed of operation was essential.

Firstly 4 passes were made West to East, full width of the road, then 4 passes North to South full width of the road. For the radius work, the bitumen supply tanker was unhooked and the radius material was pulverized only using the WR 2500, this material was then blended with the foam treated material.

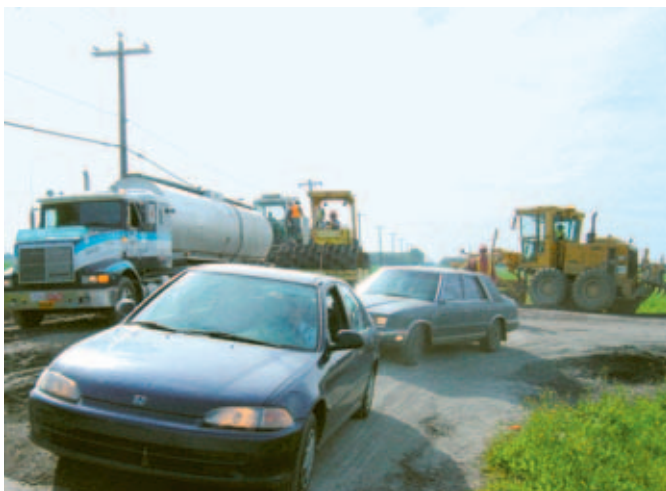
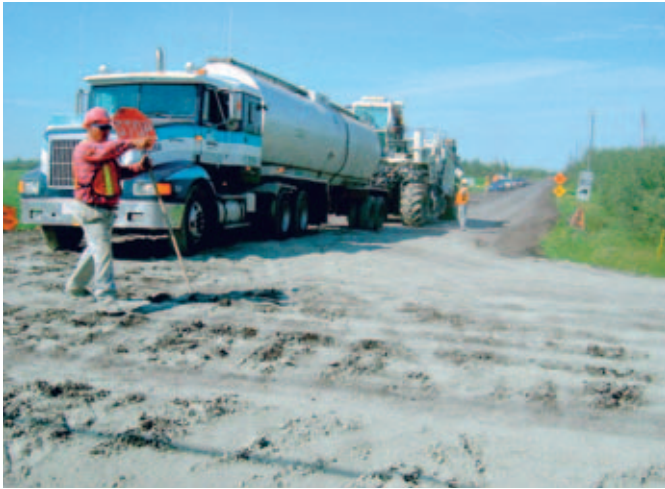
Despite the best efforts of traffic control, (trying to stop traffic from 4 directions at once), it was necessary to work continually with traffic.

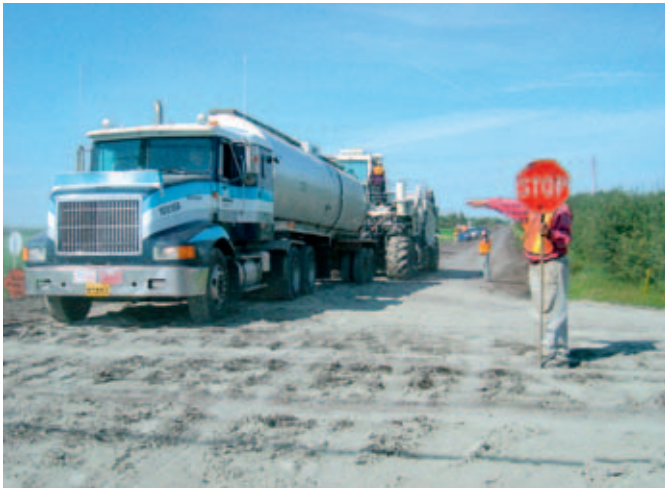
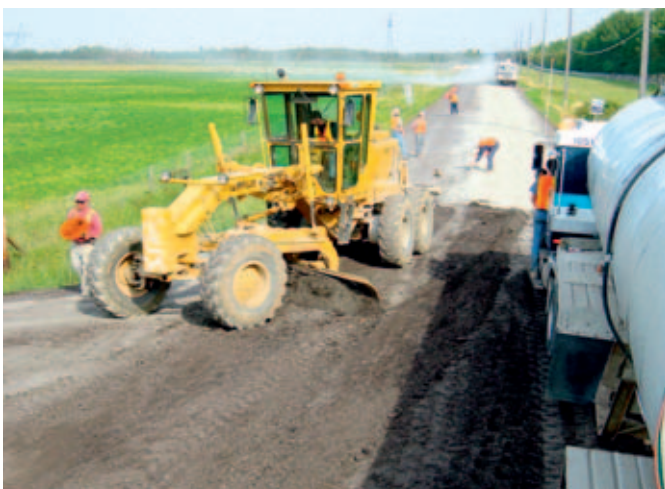
The radius material is blended with the foam treated material and then placed back into the radius ready for compaction and finishing.

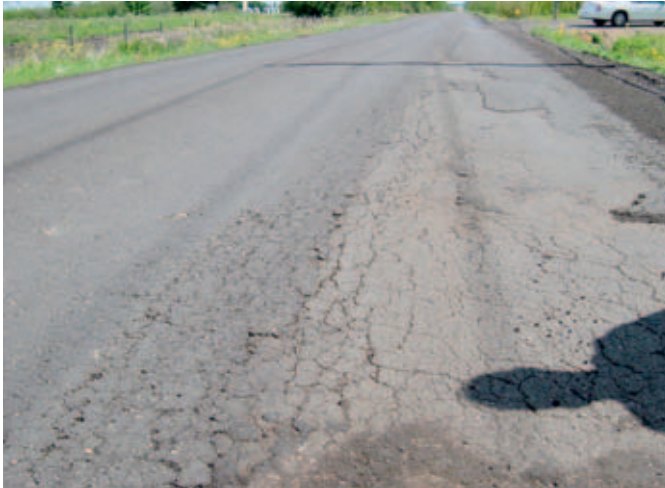
**19<sup>th</sup> August 2001**

View from start of project looking East.

The distress found was mainly severe crocodile cracking and deformation.

The cracks were evidence of fatigue failure of the upper pavement layers due to lack of subgrade support, especially when the subgrade was excessively moist. The deformation evident also pointed to movement of the subgrade and in some instances excessive bitumen in the base layer.

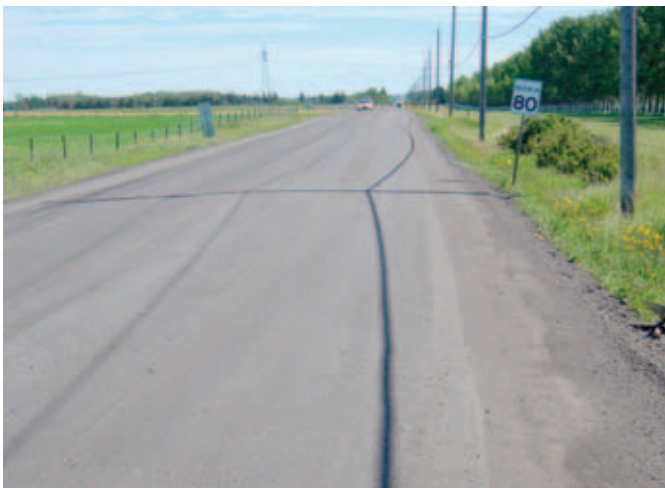
**26<sup>th</sup> August 2001**

View from start of project looking East after recycling with foamed bitumen and before sealing with asphalt overlay.

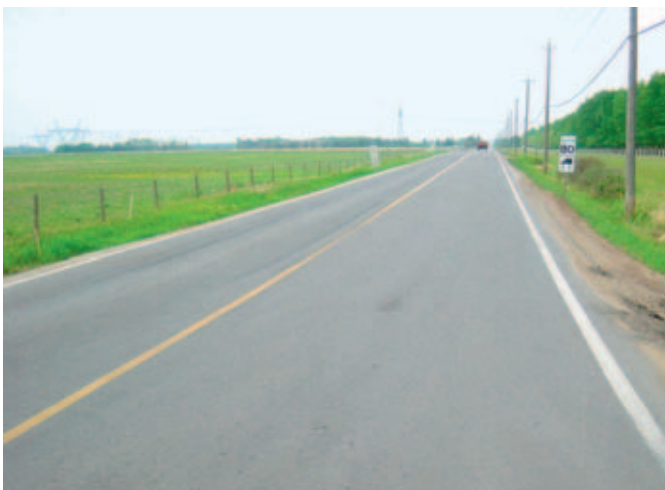
**13<sup>th</sup> June 2002**

On the 13<sup>th</sup> June 2002 it was possible to revisit the Eilerslie Road site and determine how the recycled base using foamed bitumen had withstood nearly 12 months of traffic and ambient temperatures of down to minus 22 Deg F.

No evidence of any pavement failure or distress.

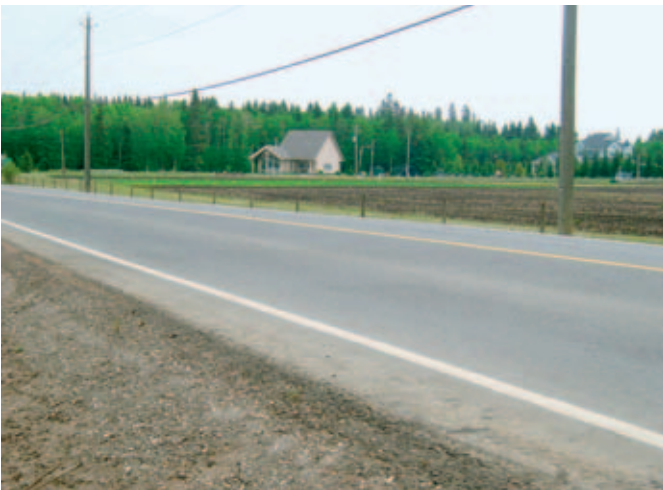
June 2002

Above section, West of 140<sup>th</sup> St.

No evidence of any pavement rutting or failure.

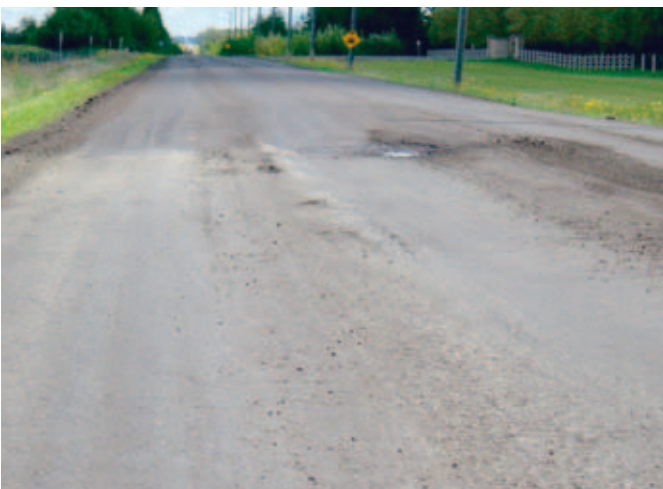
## 8.2 View looking East approx 0.5 mile from starting point

19<sup>th</sup> August 2001

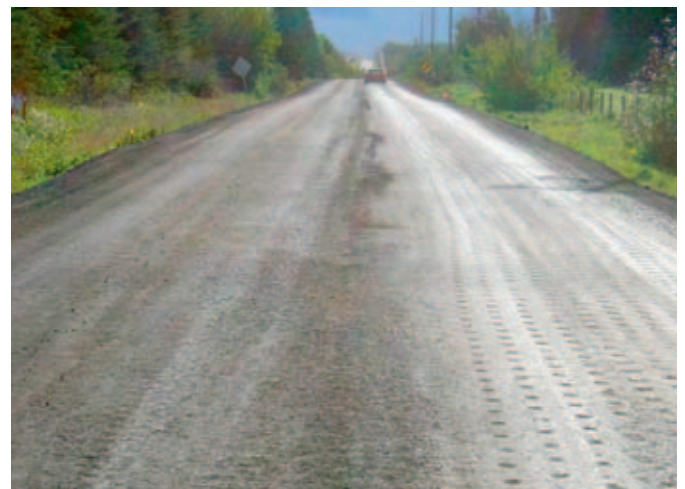
25<sup>th</sup> August 2001

Prior to final finishing with PTR
