Job Report Cold Recycling

WR 2500 S: Rehabilitation project, Iliki – Athens – Korinthos Highway, Greece

Pavement rehabilitation by recycling with foamed bitumen The Iliki – Athens – Korinthos Highway, Greece

DC Collings, Loudon International, December 2003

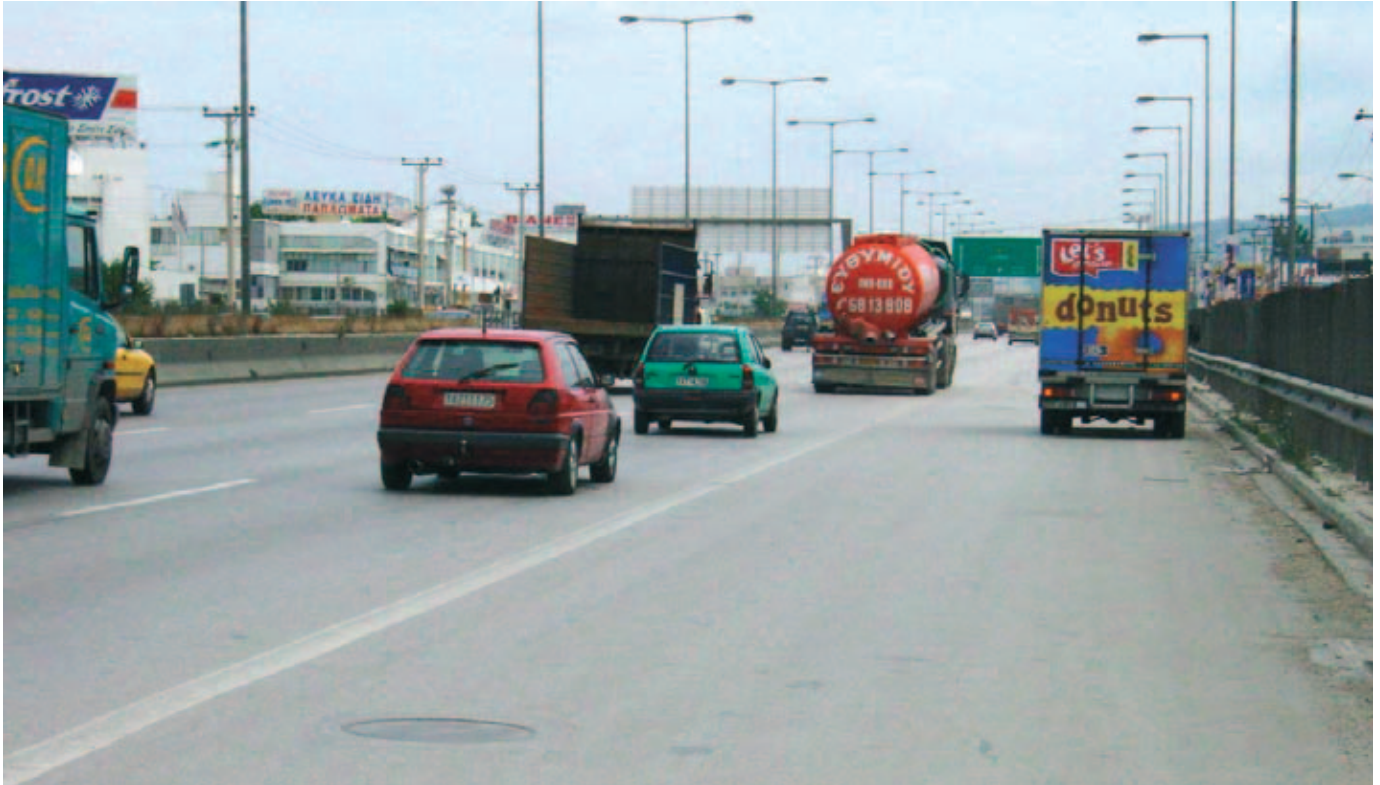
To increase the capacity for anticipated traffic growth, the original highway was upgraded to a six-lane dual carriageway some ten years ago (as shown in the above

cross-section). Traffic volumes during 2003 were in excess of 40,000 vehicles per day, with some 25 % comprising heavy vehicles.

This upgrading required widening each carriageway with new pavement layers. The resulting pavement structure therefore varied across the width, the widened portions generally included a cement-treated base whilst the original construction included both thick asphalt layers as well as graded crushed stone bases.

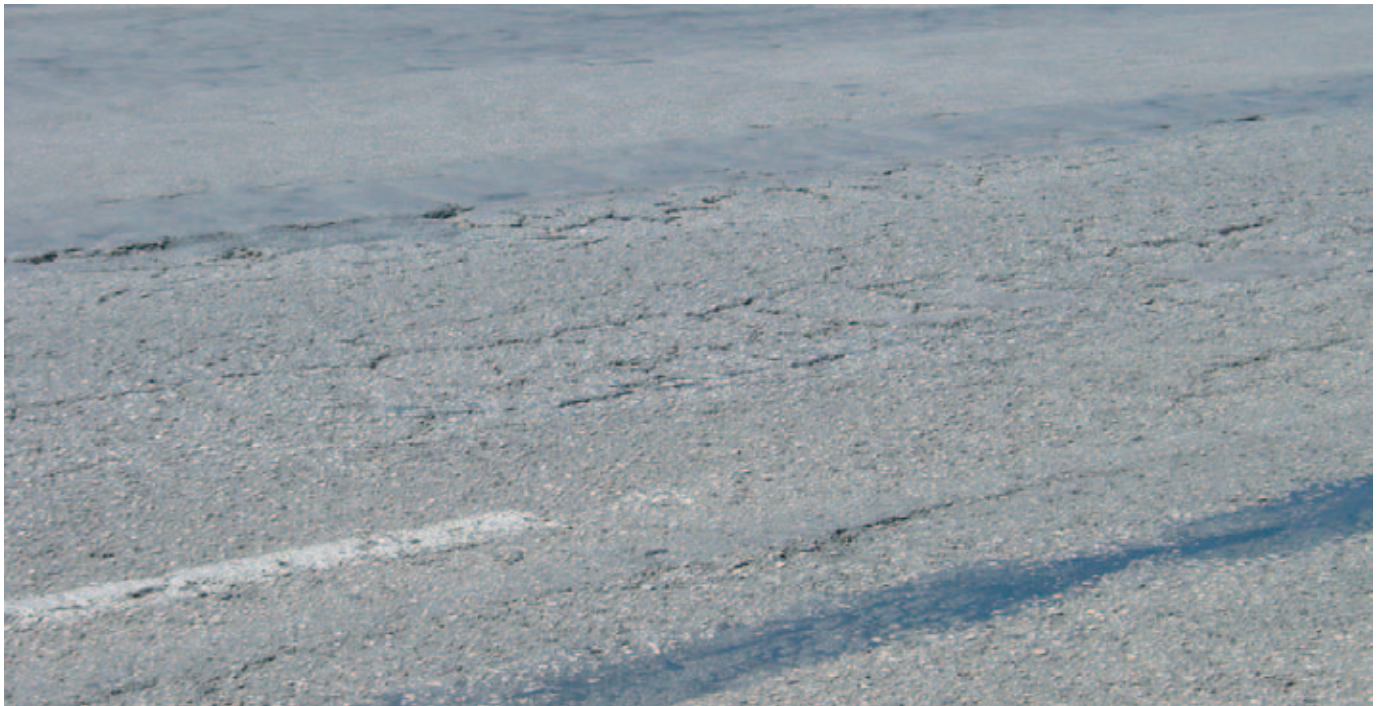
Extensive distress had occurred, characterised by crocodile cracking and deformation. These failed areas had been repaired by excavating to depths varying from 75 mm to over 300 mm and backfilling with hot-mix asphalt, thereby compounding the non-uniformity of the pavement structure.

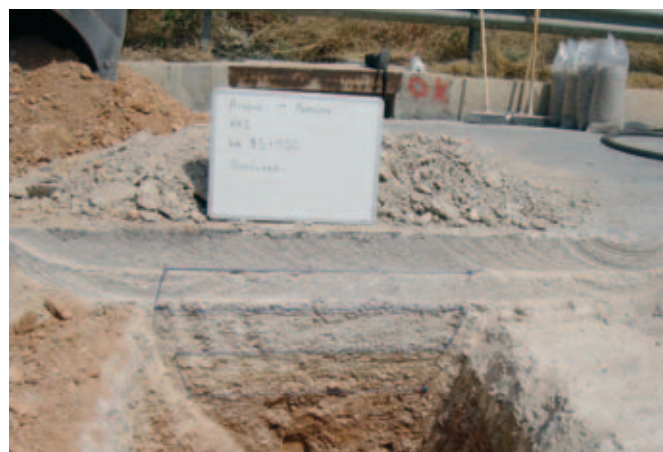
At least one testpit was excavated in each uniform section identified from FWD analyses. Additional testpits were also excavated in areas of severe distress as well as areas with little or no distress in an attempt to understand the mechanisms causing distress in the pavement. Test pits were excavated using a Wirtgen W 1000 milling machine to remove the asphalt and layers of cemented base material. A backhoe excavator was then used to remove the underlying materials to a depth of 1 m.

The overall objective of excavating these test pits was to identify the pavement profile. This included:

Standard soil tests (CBR, Atterberg limits and sieve analysis) were carried out on these samples in order to classify the various materials originally used to construct the pavement.

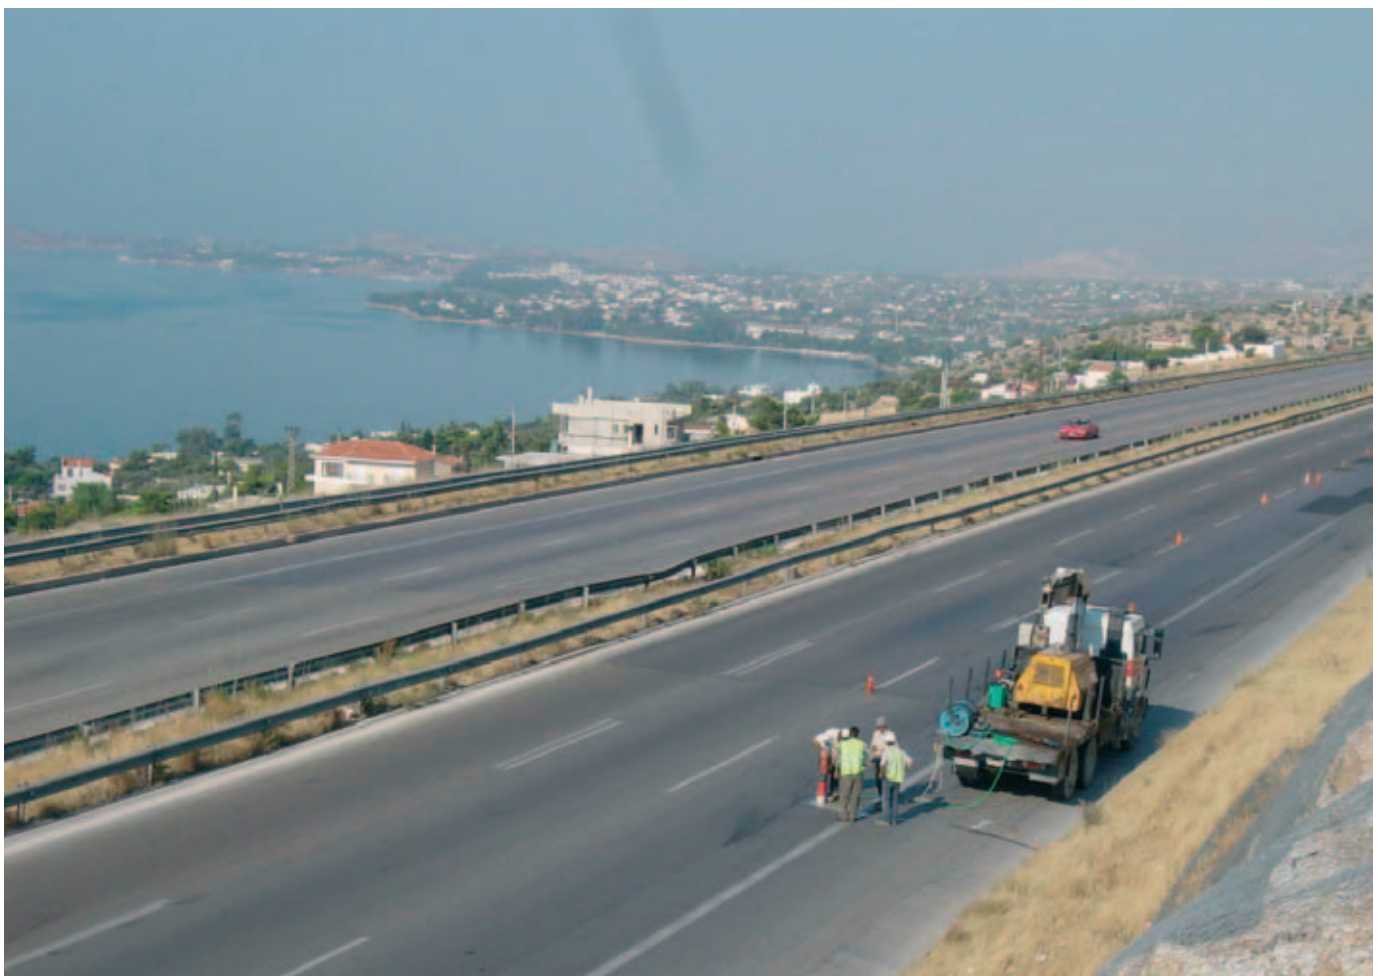
The purpose of extracting these cores was to determine:

The core investigation confirmed the various pavement structures identified from the testpits and provided the information required to identify uniform sections of similar pavement structure. These uniform sections, originally identified from deflection measurements, were thus confirmed or re-defined.

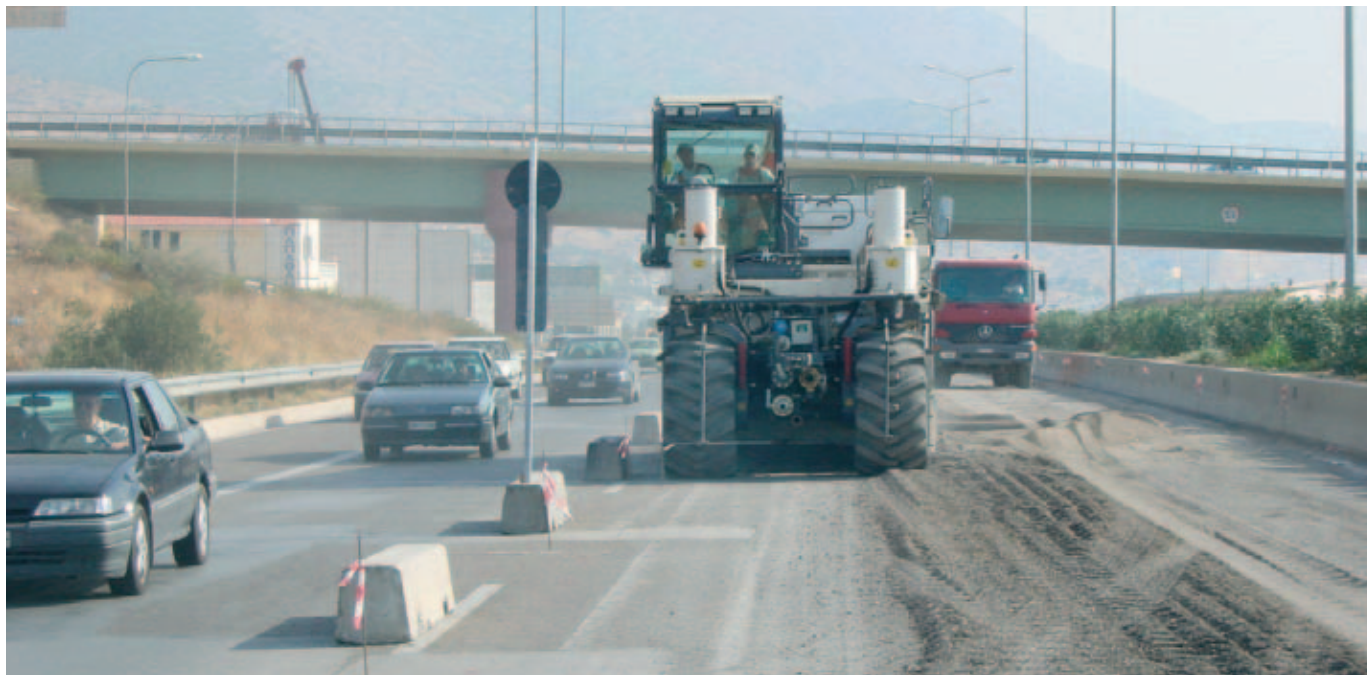
Prepulverising with the Wirtgen WR 2500 S.

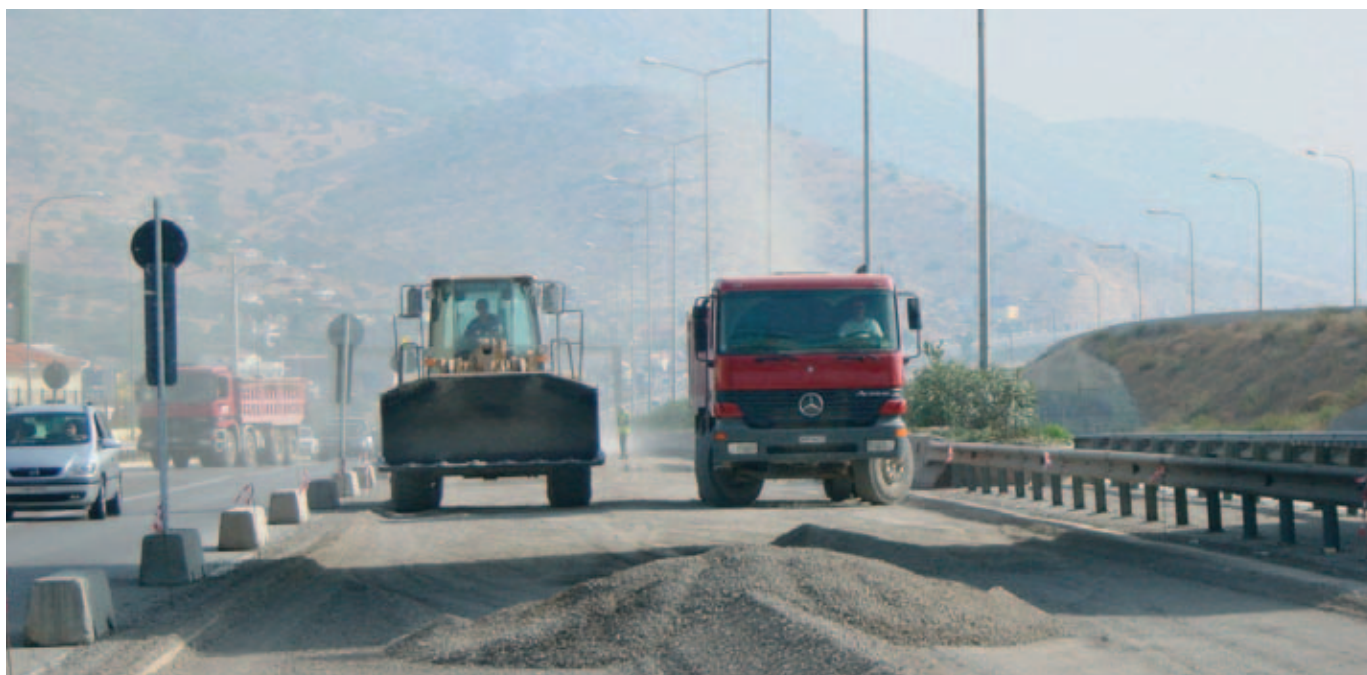
Removing surplus material.

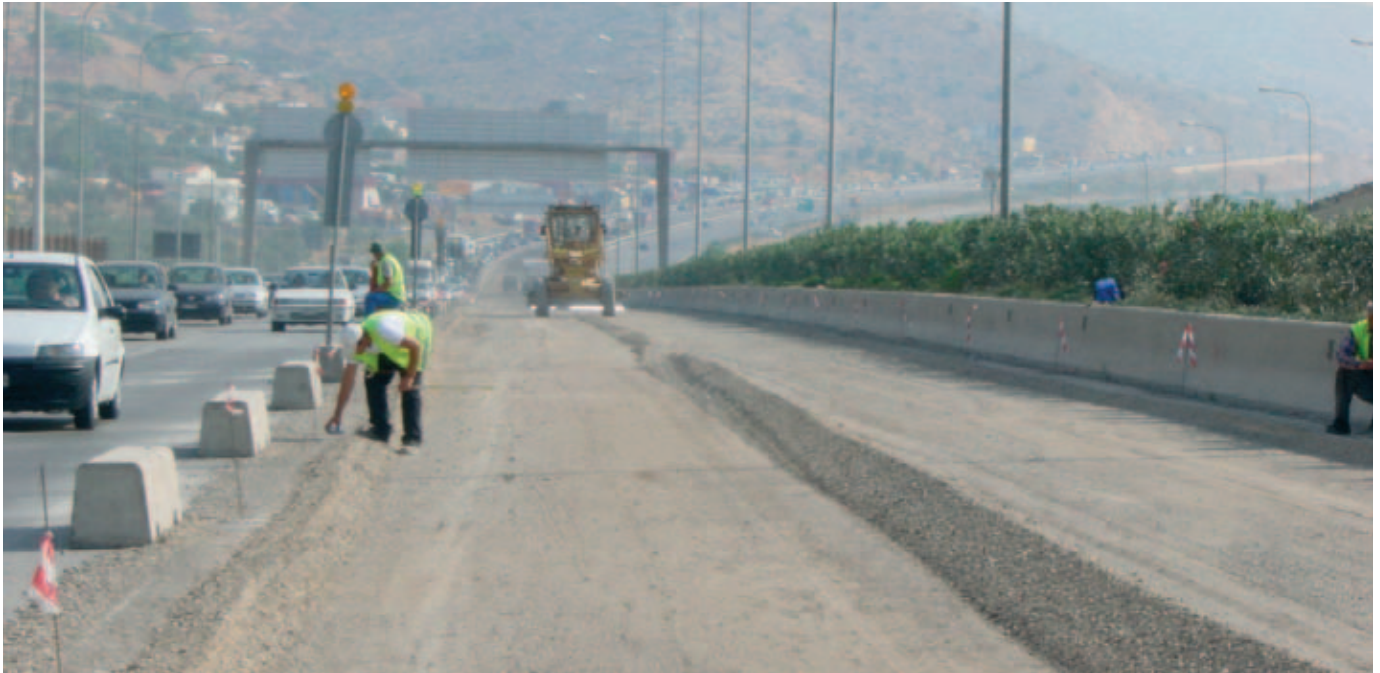
Cutting surface levels prior to stabilising.

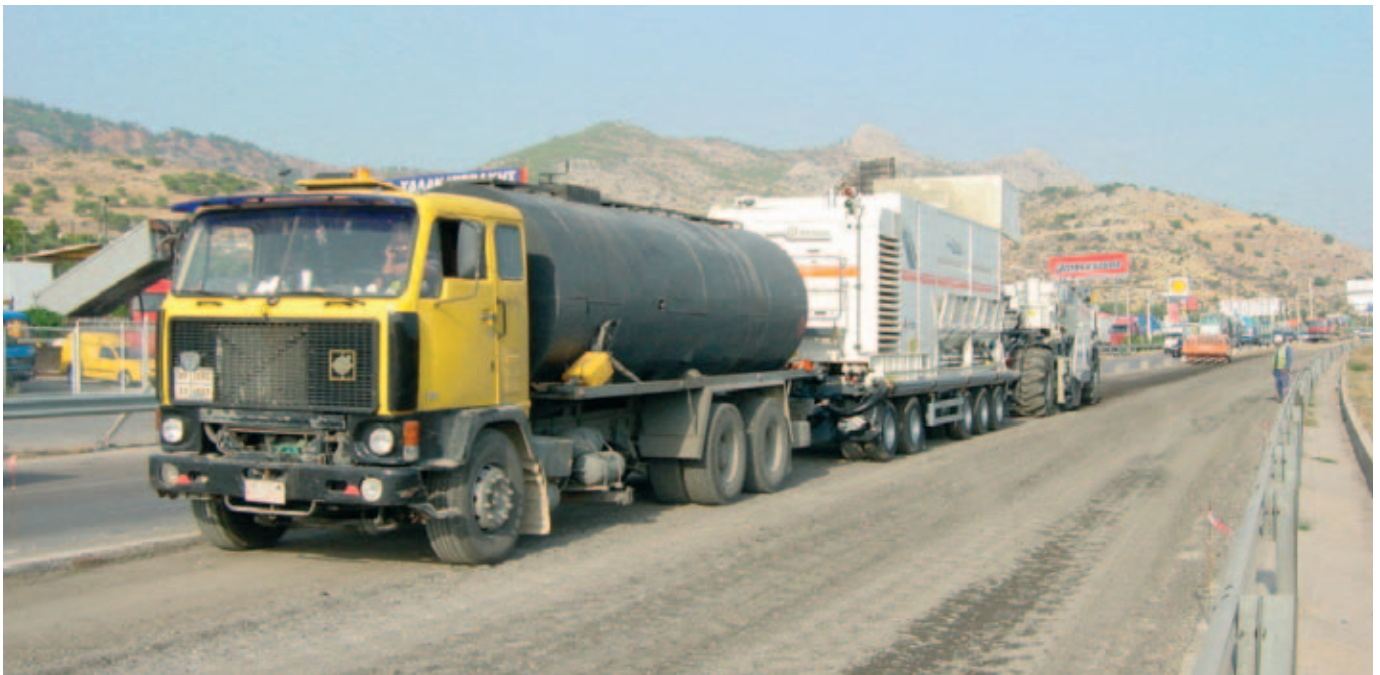
The recycling train, consisting of a tanker filled with hot (175 °C) bitumen, a Wirtgen WM 1000 cement slurry mixer (described below), both pushed by the Wirtgen WR 2500 S recycler.

The recycling train.

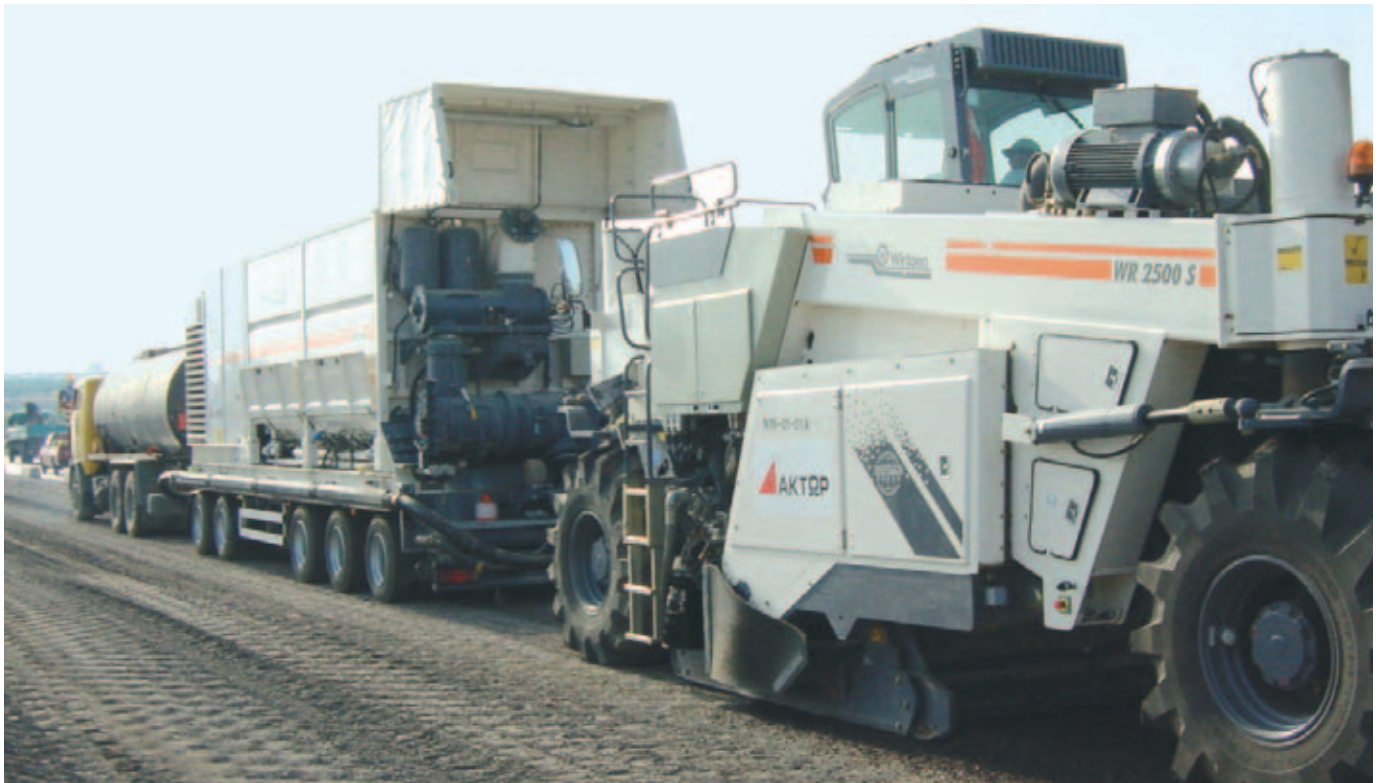
The Wirtgen WR 2500 S recycler.

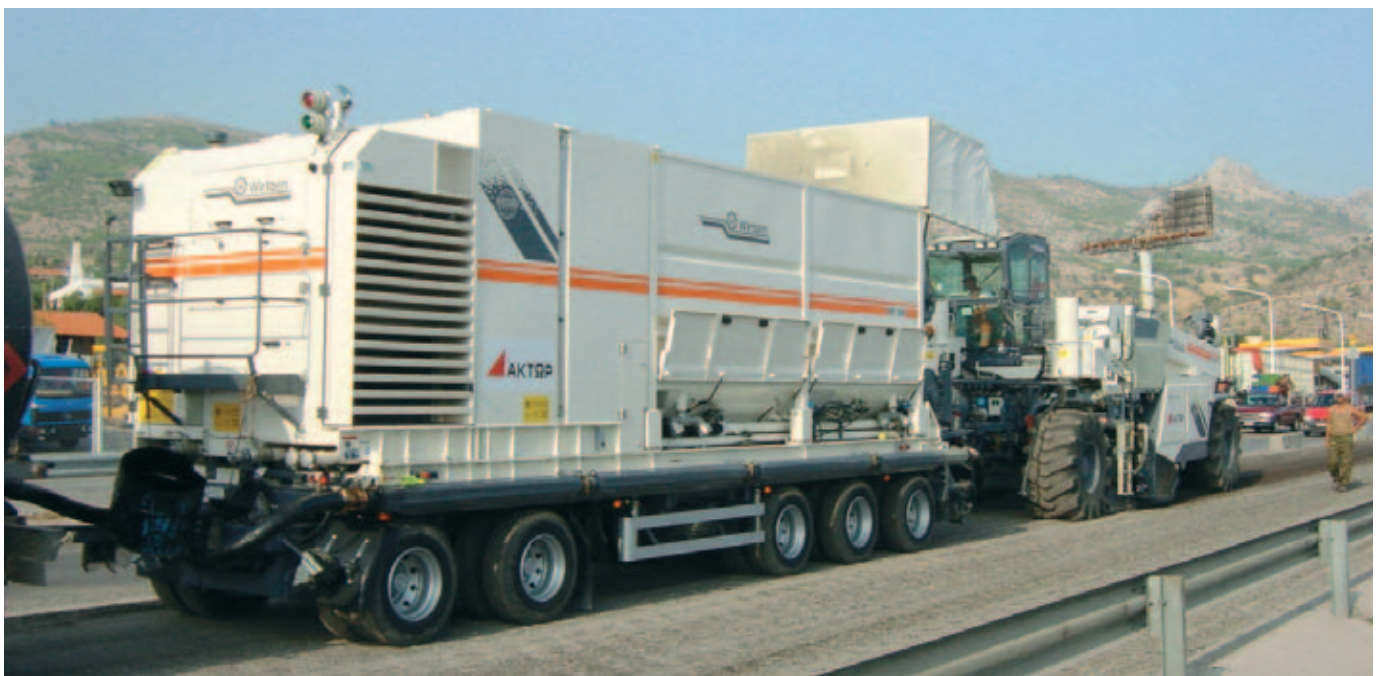
The Wirtgen WM 1000 cement slurry mixing unit manufactures up to 1000 litres of cement slurry per minute, drawing from on-board storage facilities. The amount of water added is adjusted to meet the moisture demands of the recycled material. The slurry is pumped to the recycler where it is injected into the milling chamber under pressure through a spraybar separate from the one used to foam bitumen, thereby ensuring the best mix quality possible.

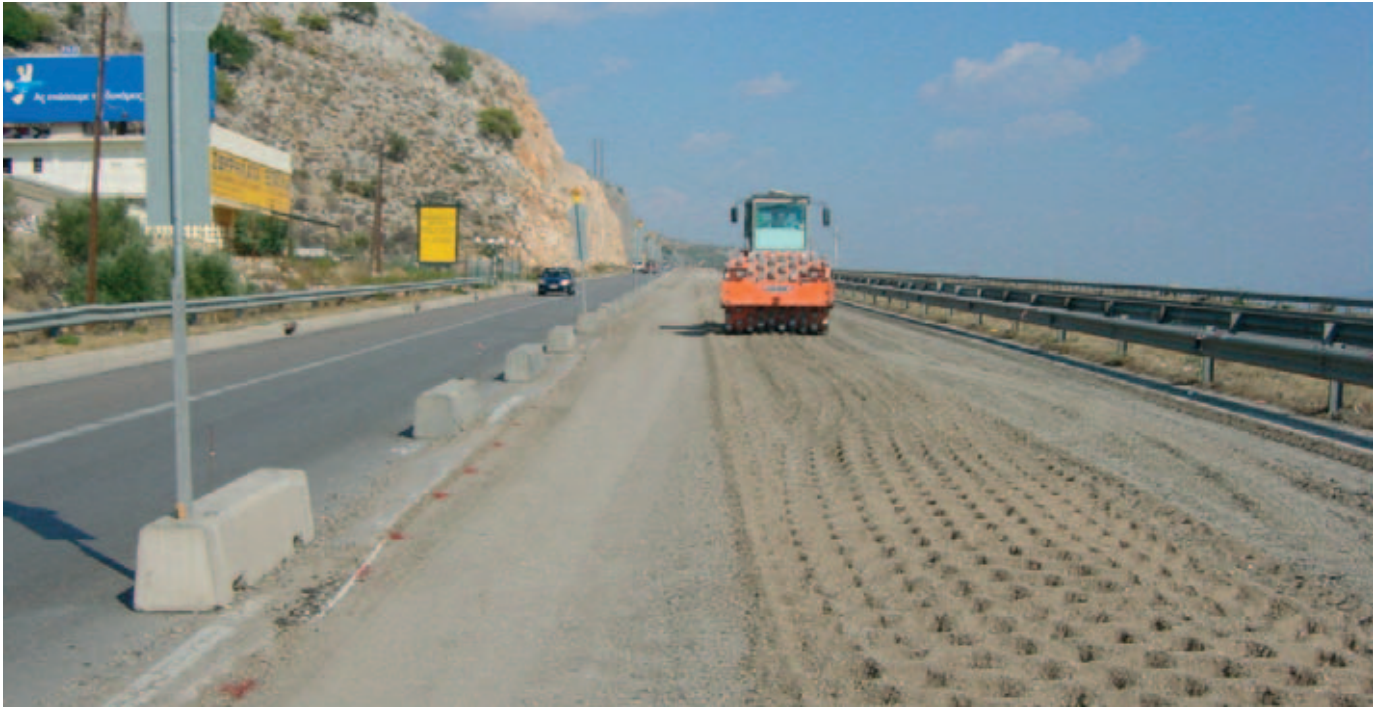
Primary compaction applied immediately behind the recycler by means of a 20-ton vibrating padfoot roller. This roller is fitted with a compactometer that monitors the degree of densification achieved in the recycled layer. Rolling continues until this meter indicates that the maximum density achievable has been obtained (normally between 9 and 15 uni-directional passes). The average density achieved is equivalent to 102 % of modified Proctor density.

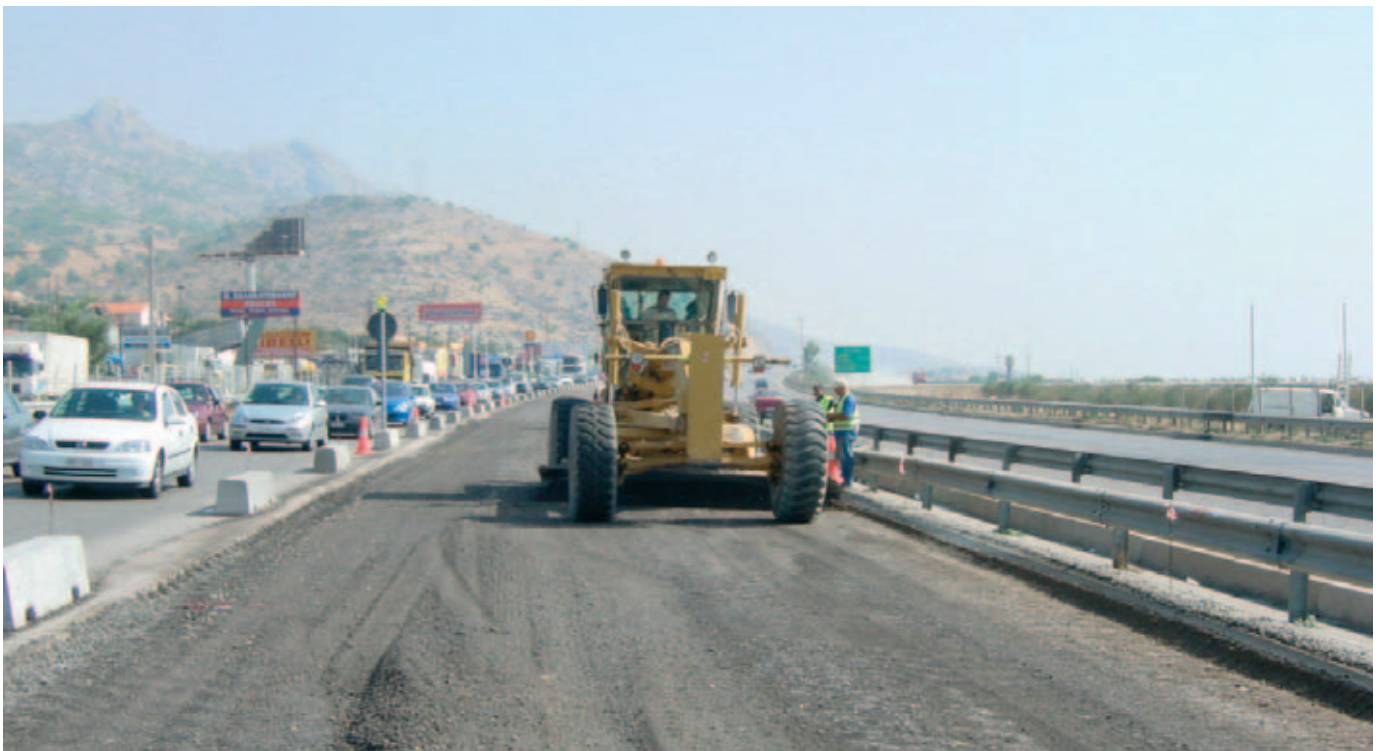
Cutting final surface levels by grader after the three adjacent cuts that have been recycled and compacted by padfoot rolling.

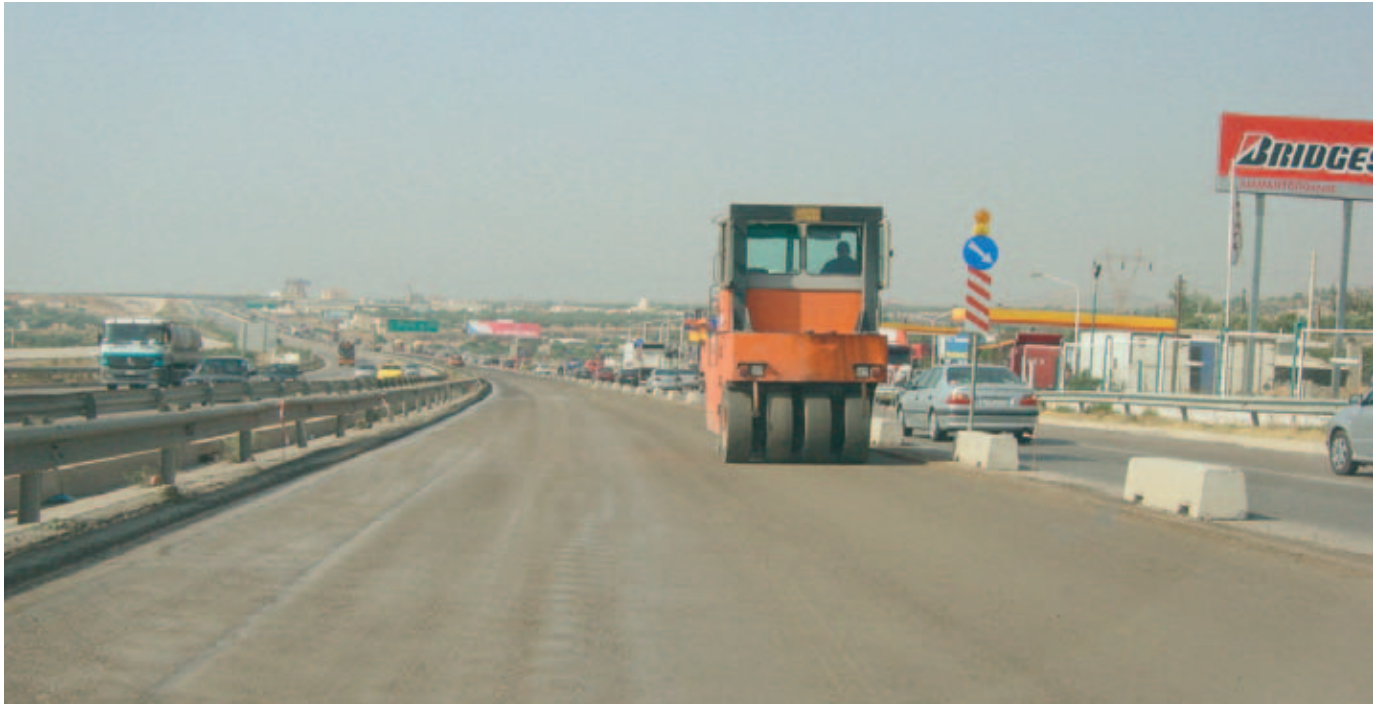
Compacting the upper portion of the layer disturbed by cutting levels using a smooth-drum vibrating roller. Water is sprayed on the surface prior to and during compaction, as demanded by ambient conditions.

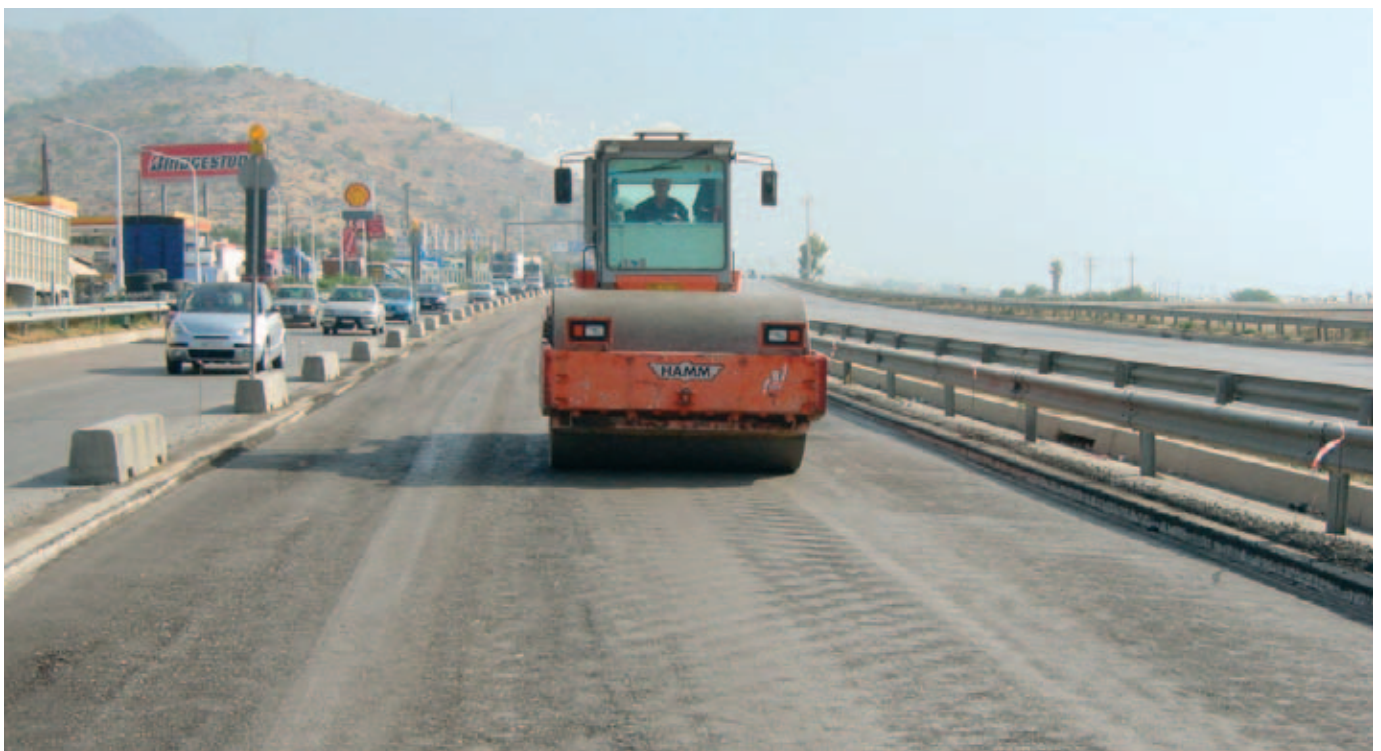
Finishing to achieve a tightly-knit surface using a pneumatic-tyred roller. Generous applications of water are applied whilst rolling, thereby generating a "slush" to close surface voids.

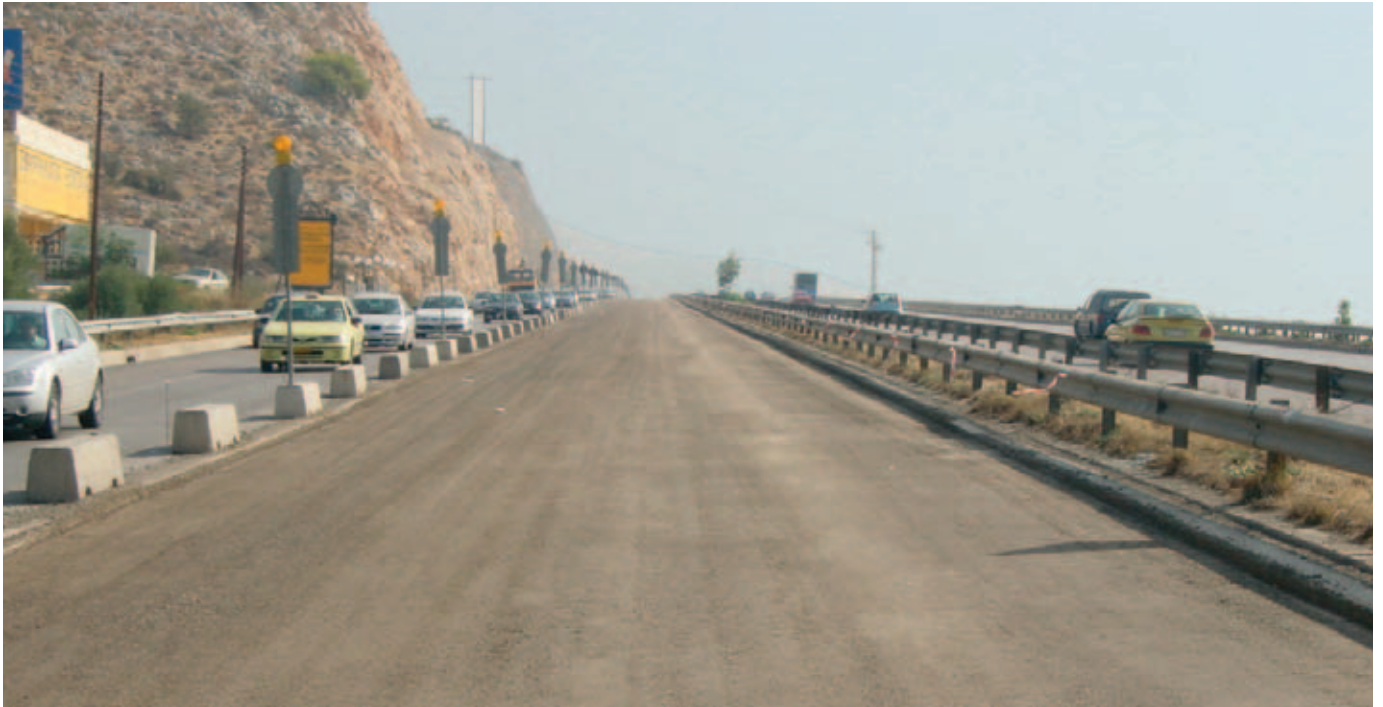
The completed base. Provided the surface is maintained in a moist state or protected by a light fog spray of diluted emulsion, this base may be trafficked for several days before applying the surfacing.

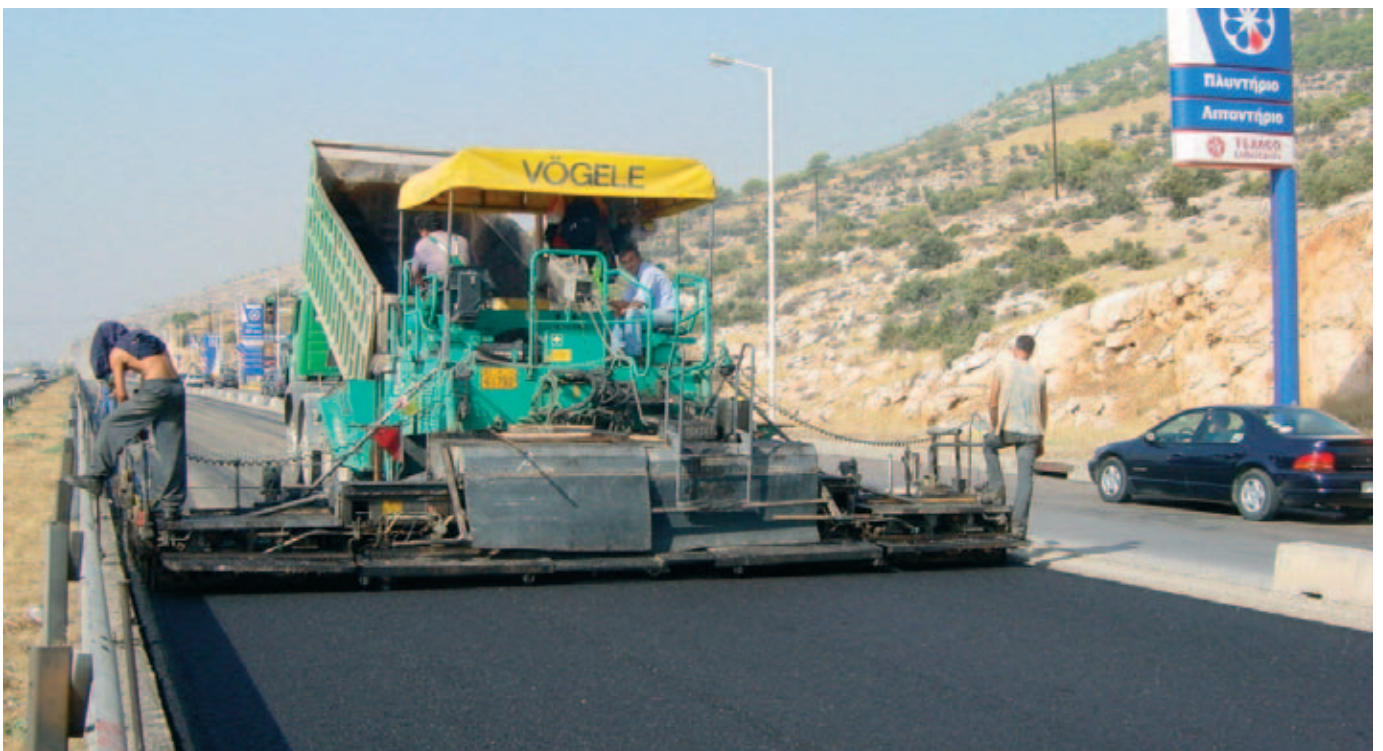
A Vögele Super 1800 paver applies the 50 mm asphalt binder layer, full width.

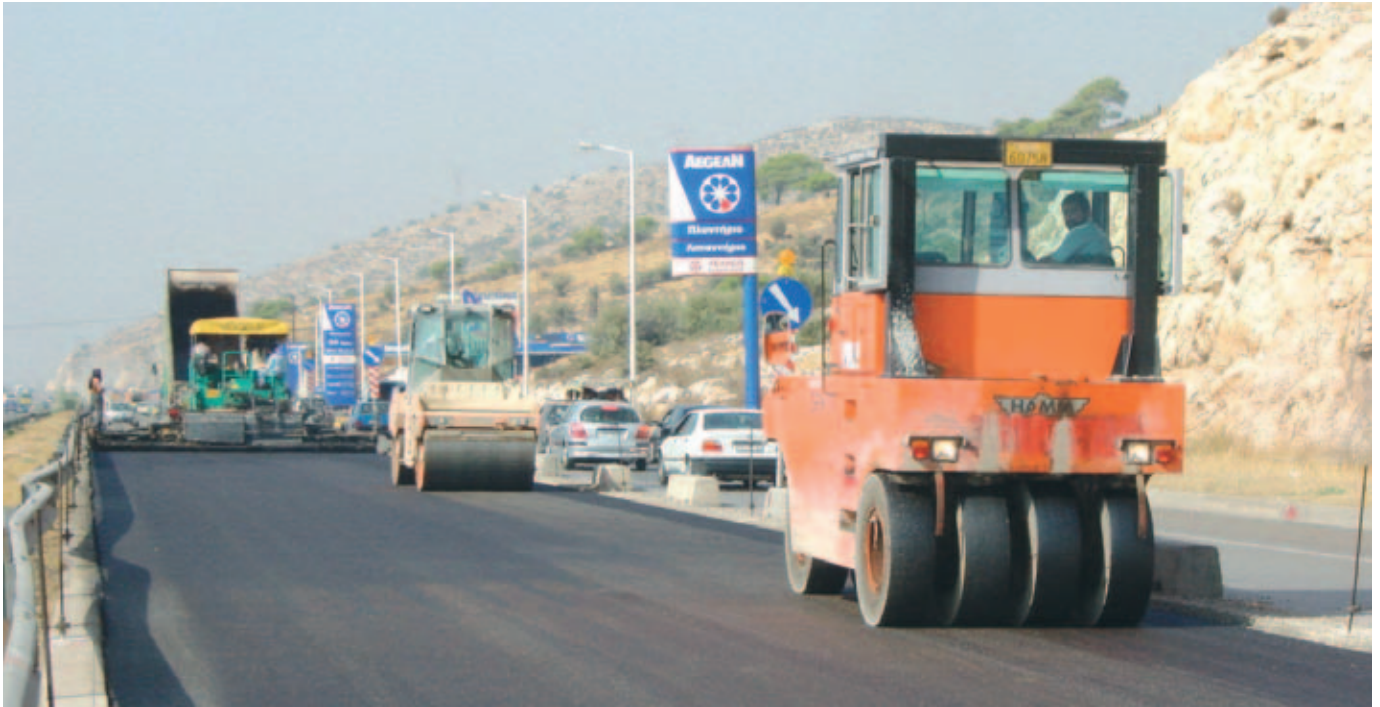
After compaction and applying temporary road markings, the traffic is moved onto the completed pavement.

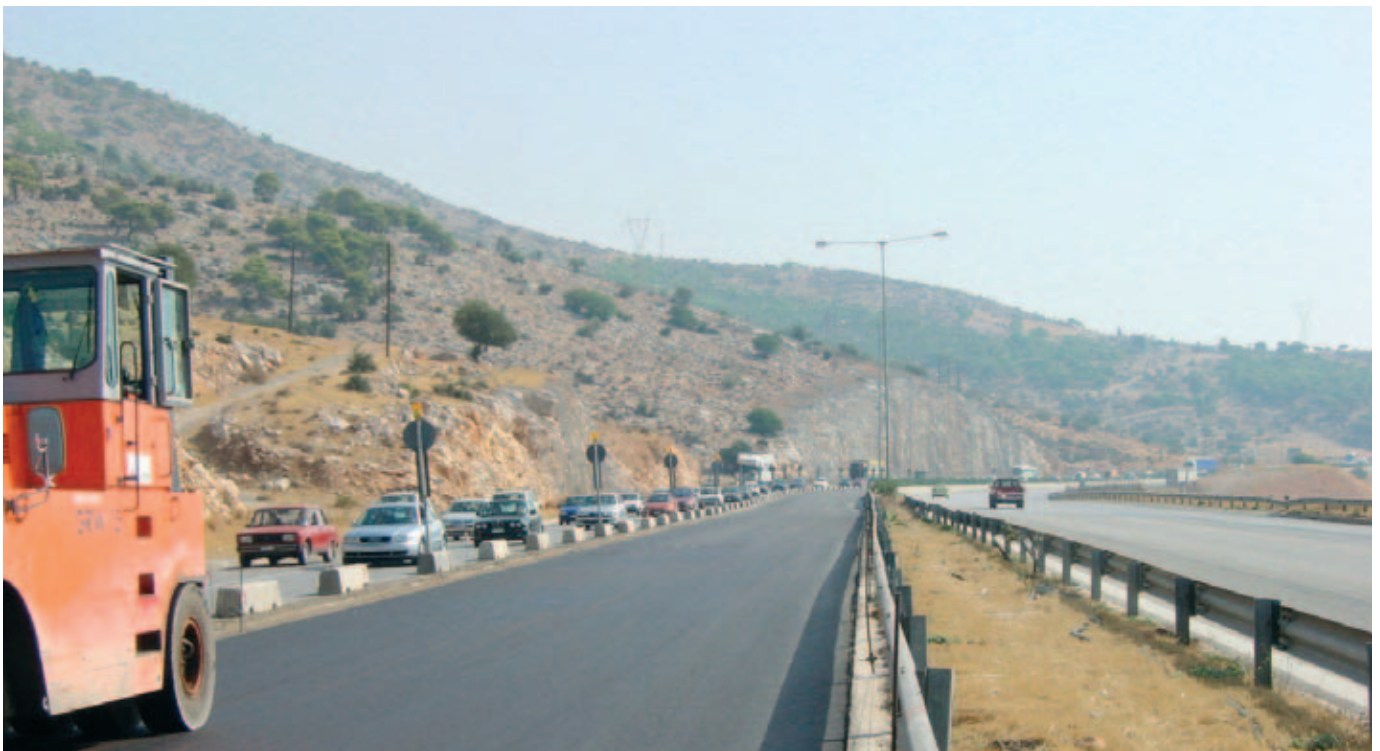
The outer half of the carriageway is then recycled.
