Job Report Cold Recycling

# WR 2500: Rehabilitation of the Tabarja – Chekka Highway, Lebanon

Armin Janani, SOTEG S.A.R.L., December 2003

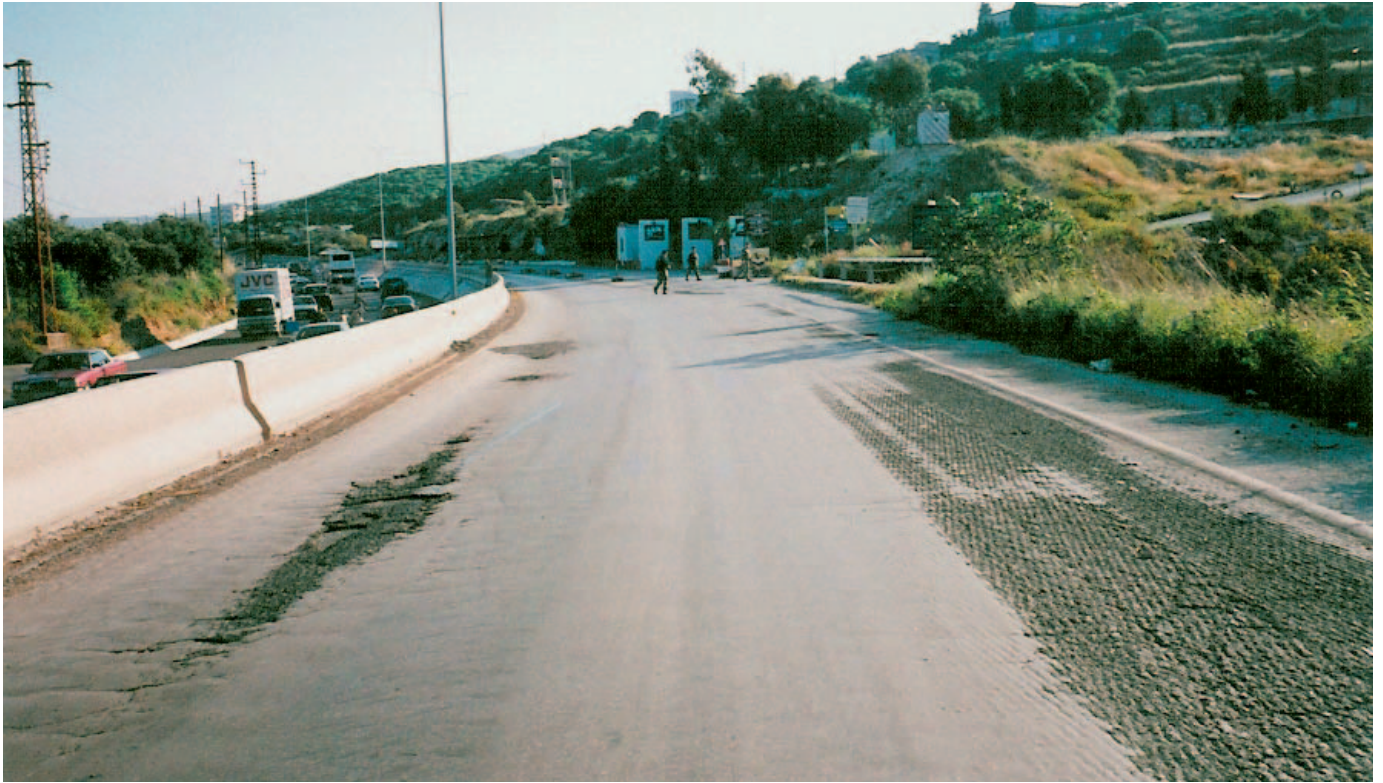
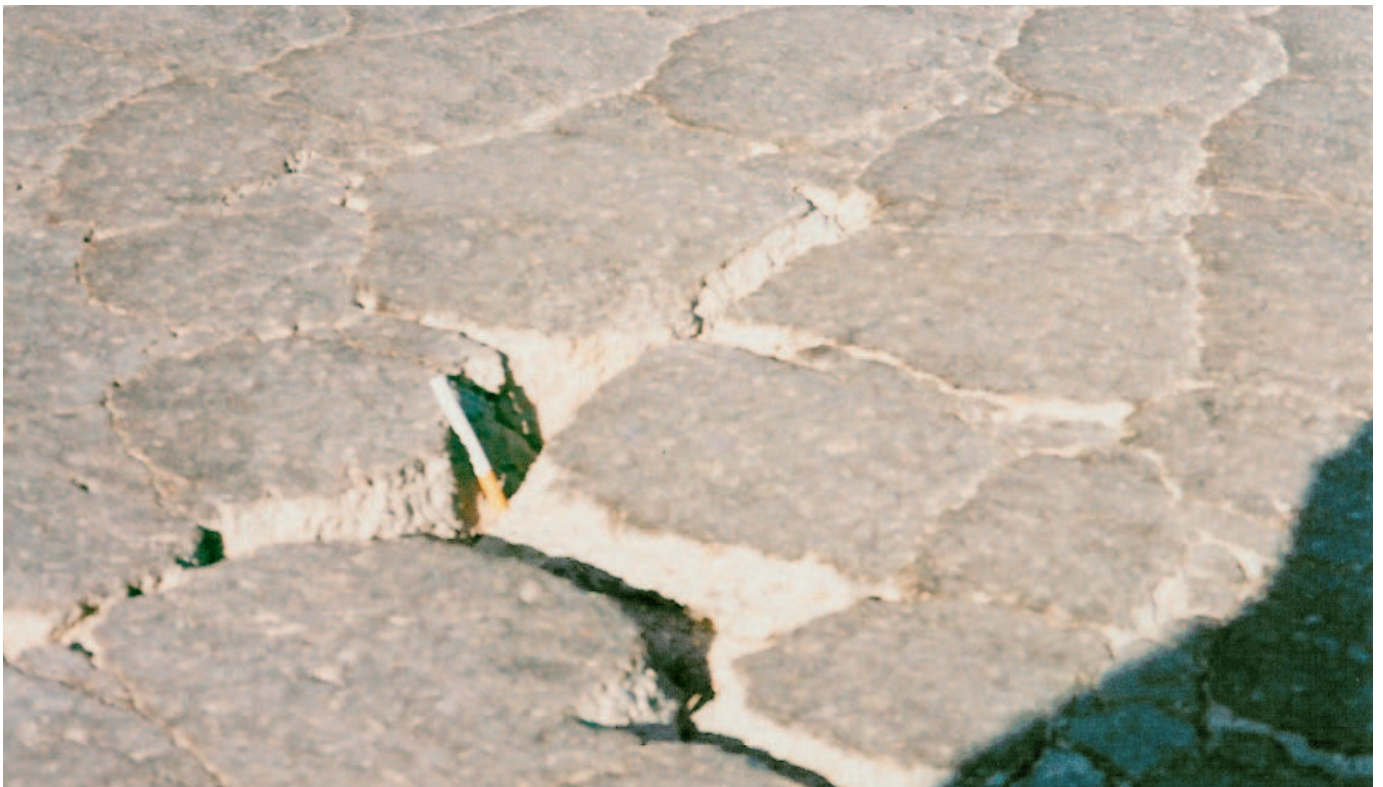
lems such as bleeding in vast areas, rutting, and parts which were patched and filled, different types of crocodile cracking, longitudinal and transverse cracks, this part of the highway was to be rehabilitated. The total length of this part is 80 km (660.000 m<sup>2</sup>) from Tabarja to Chekka and vice versa with varied widths in special sections.

Typical pavement condition prior to recycling.

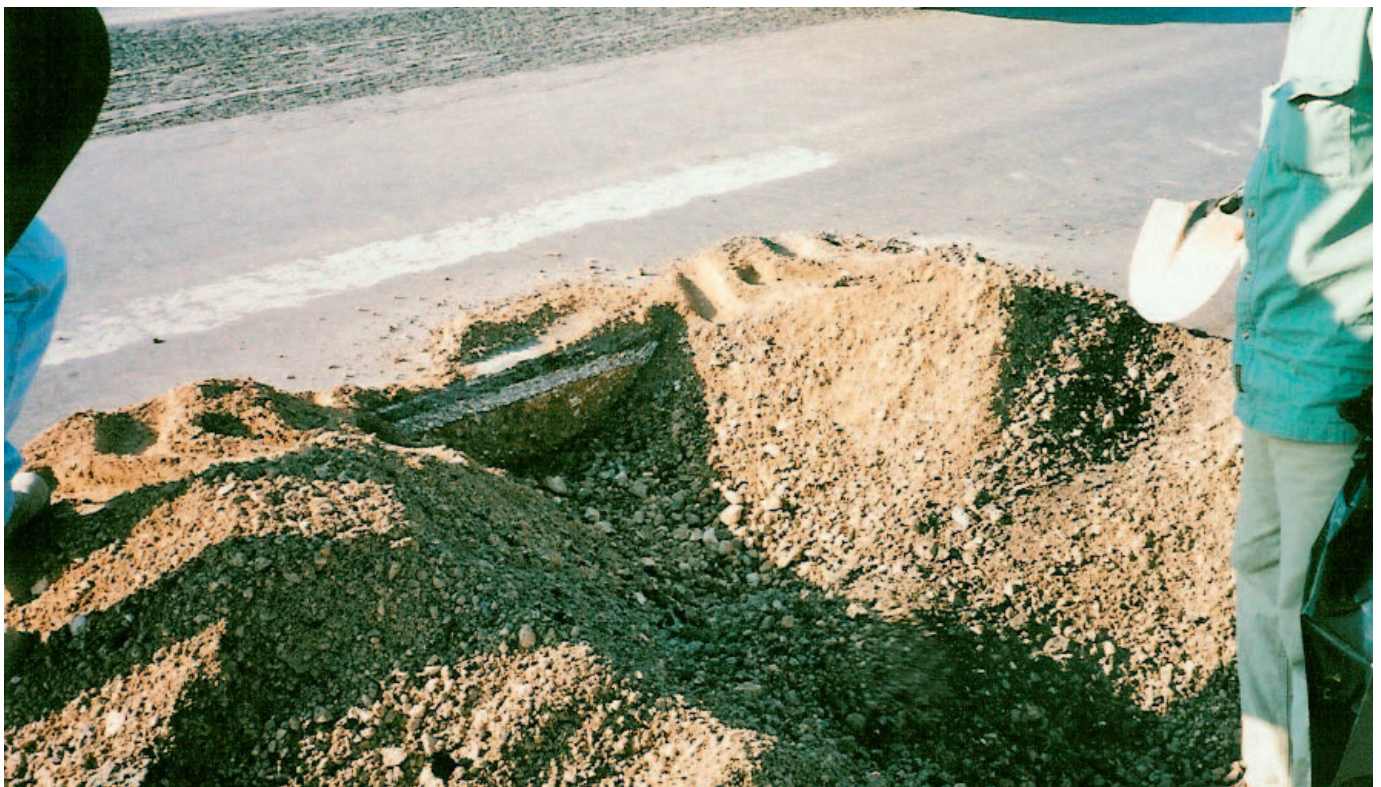
- The number of asphalt layers and their thickness
- The thickness of the base and sub-base layers
- Plasticity index of the selected base and sub-base
- Extraction of the selected asphalt samples
- Proctor test
- Gradation control

Pavement structure.

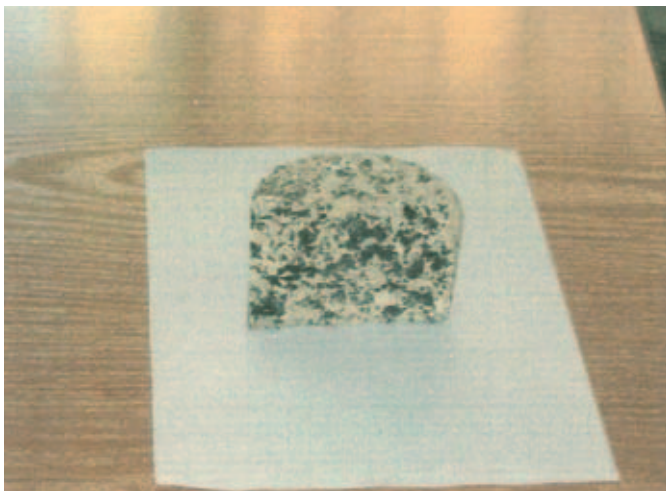
Samples were taken from the recycled material and 9 briquettes were prepared. The tests which were carried out to control the quality of the recycling process were:

Foamed bitumen samples.

- Dry ITS (min. 200 kPa)
- Soaked ITS (min. 100 kPa)
- Soaked Marshall stability (min. 700 kg)
- Extraction
- Moisture content

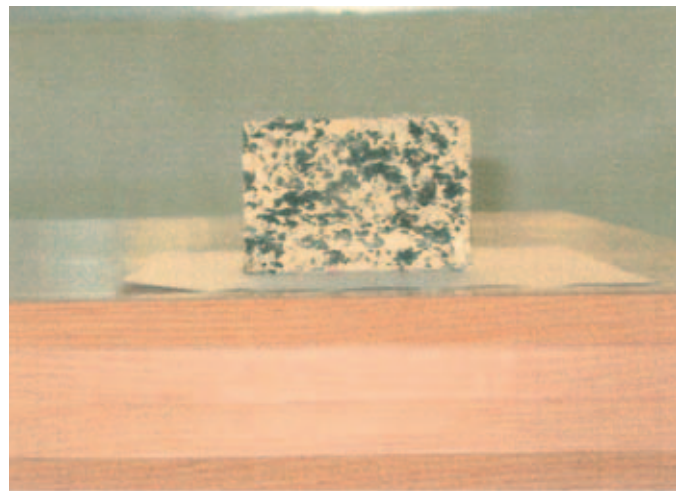
- Performance of a 25 cm depth test pit with the WR 2500 every 500 m to take out the samples for determining the moisture, bitumen content and the gradation of the mixture of ABC and asphalt.

Based on the above mentioned secondary analyses, the correspondent mix design for that specific part was applied, re-defining the gradation by adding fillers or other sizes, particularly in the areas which were stabilized by cement.

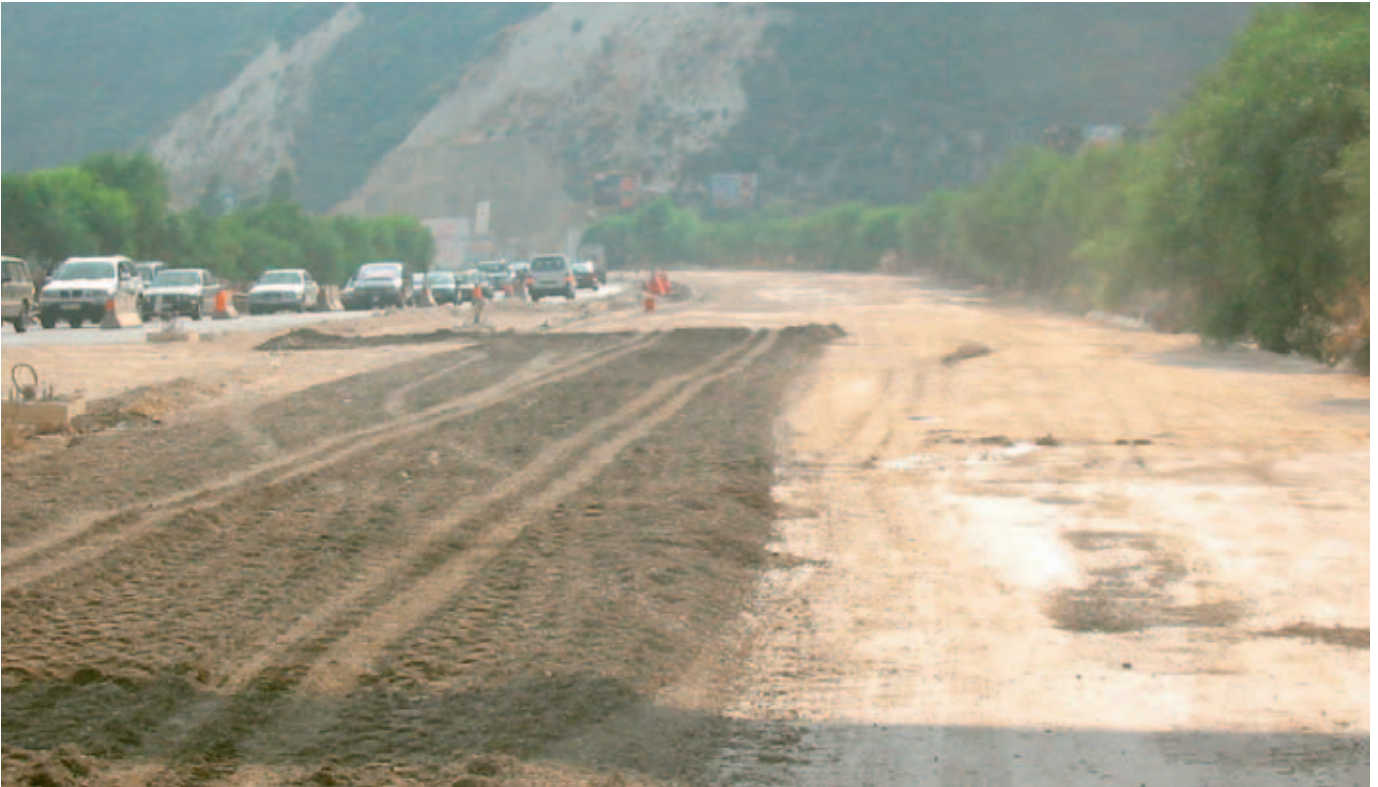
Spreading the recycled material to get the required profile.

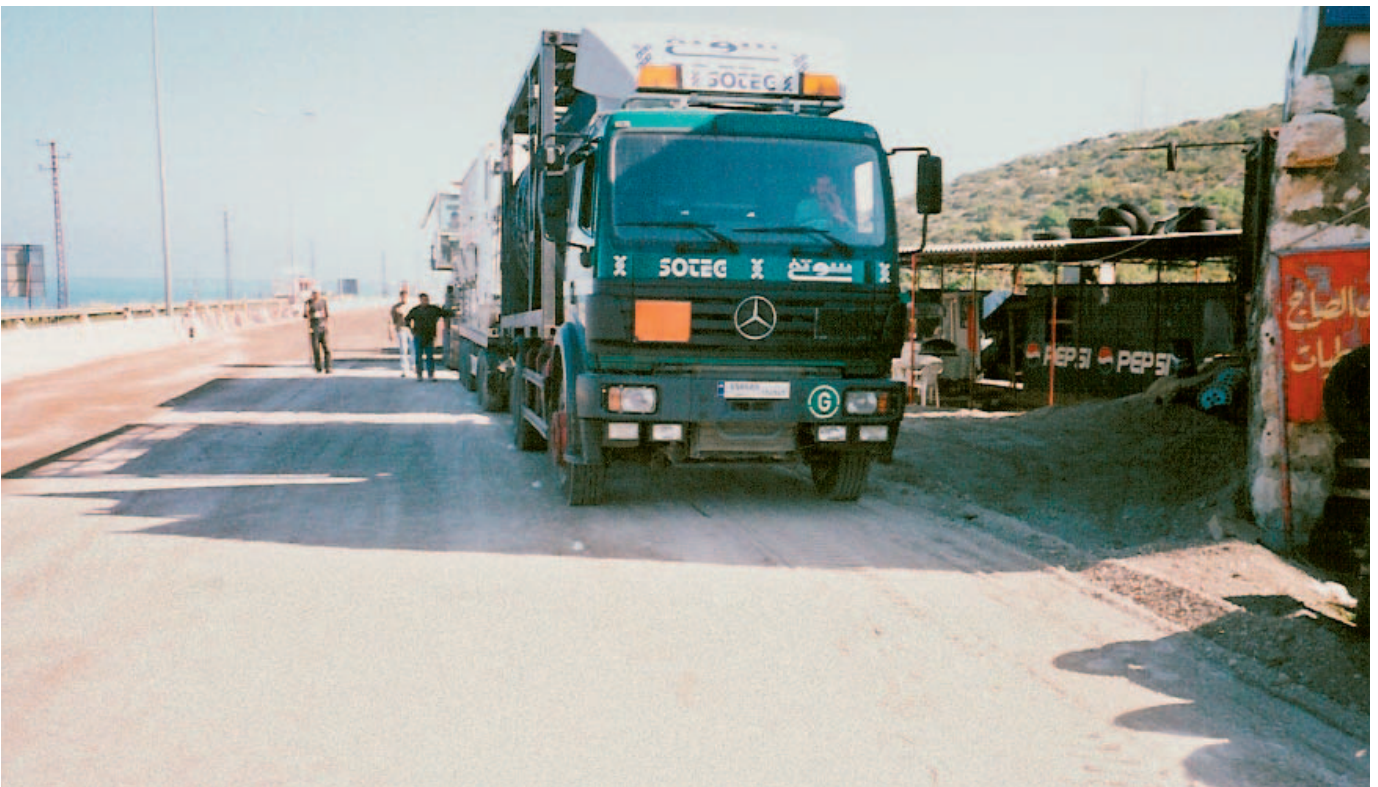
Spreading fines to modify the gradation.

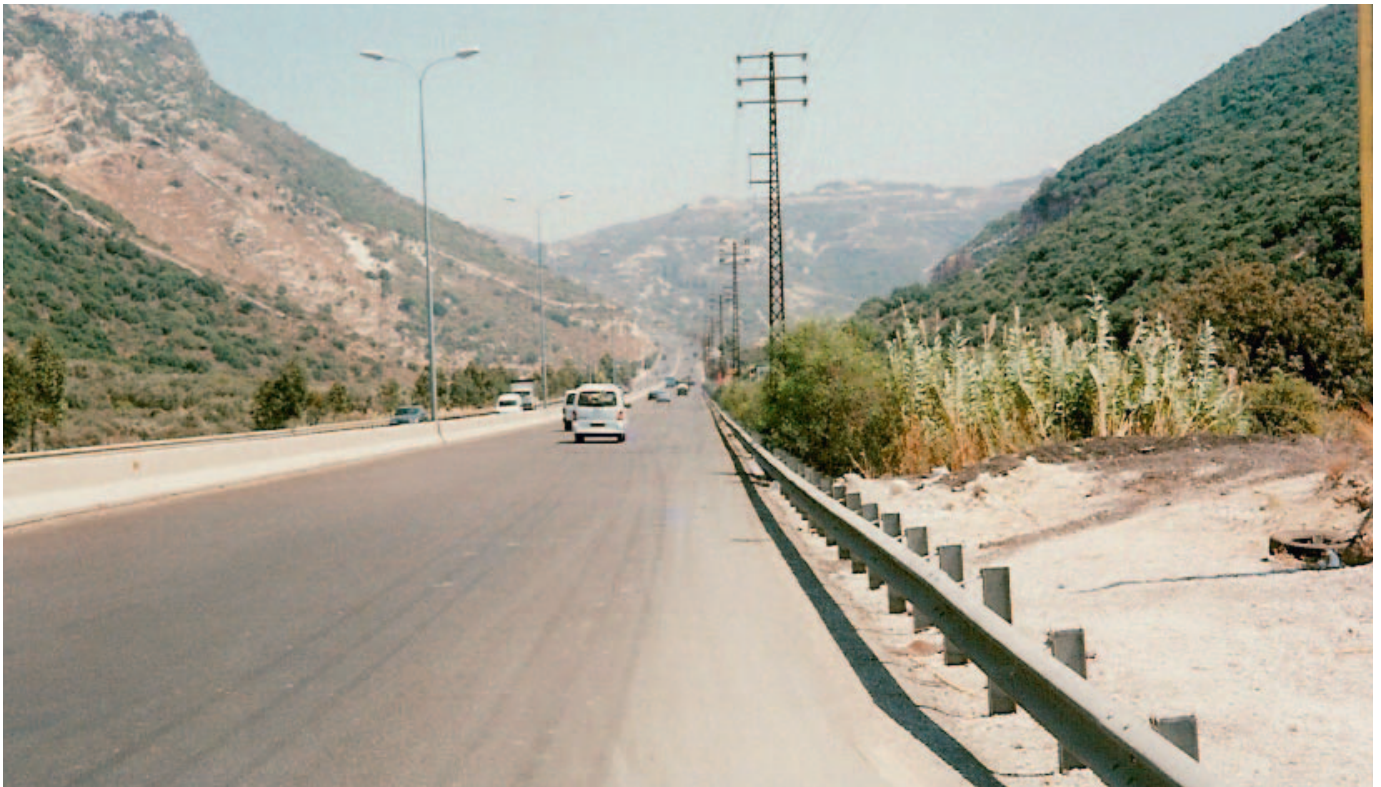
The rehabilitated highway with the asphalt overlay.

The project time was 6 months and 660,000 square meters were recycled. Up to the time when this report was prepared the first asphalt layer was executed. The foam bitumen technology proved to be a fast, cost effective, reliable, and environment friendly solution for the future of this road considering the increasing traffic load.
